# A Hydrologic Assessment of the September 14, 1974, Flood in Eldorado Canyon, Nevada

GEOLOGICAL SURVEY PROFESSIONAL PAPER 930

By PATRICK A. GLANCY *and* LYNN HARMSEN

*A presentation of hydrologic data and interpretations,  
eyewitness accounts of destruction,  
and documentation of flooding*

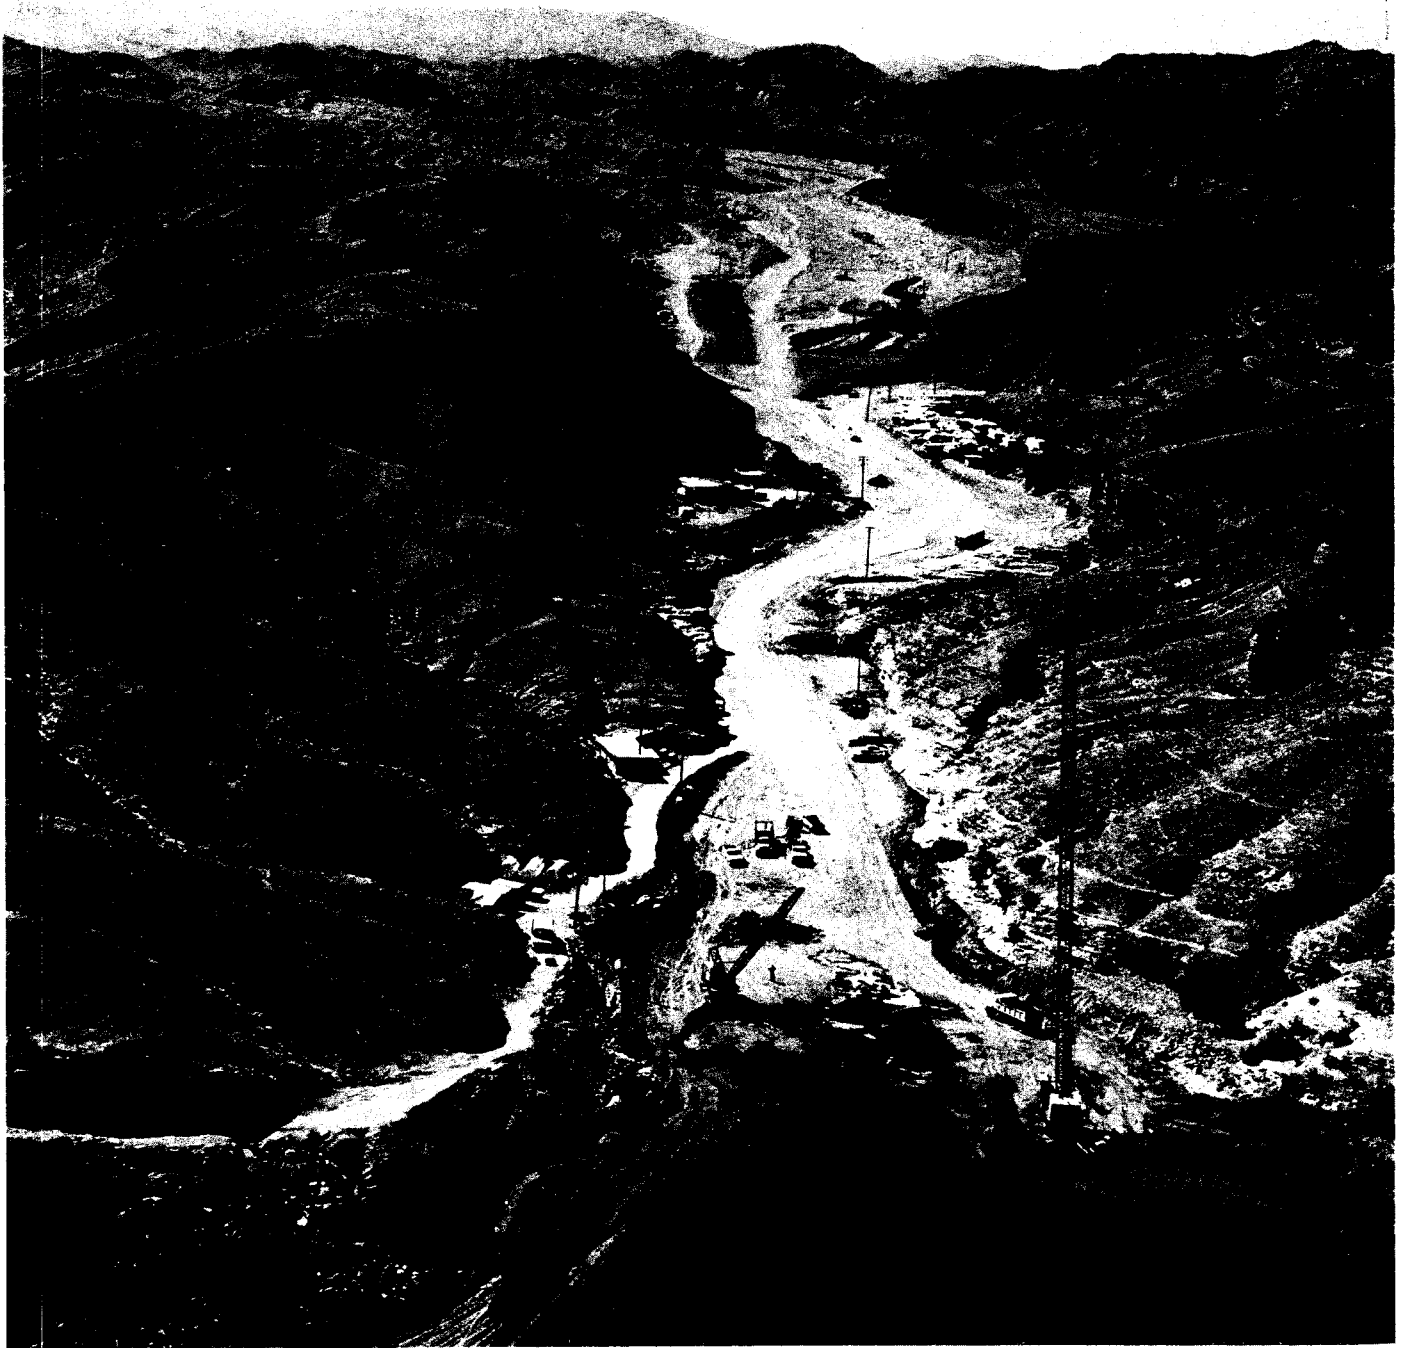
Aerial view of Eldorado Canyon looking upstream (west) on September 30, 1974.

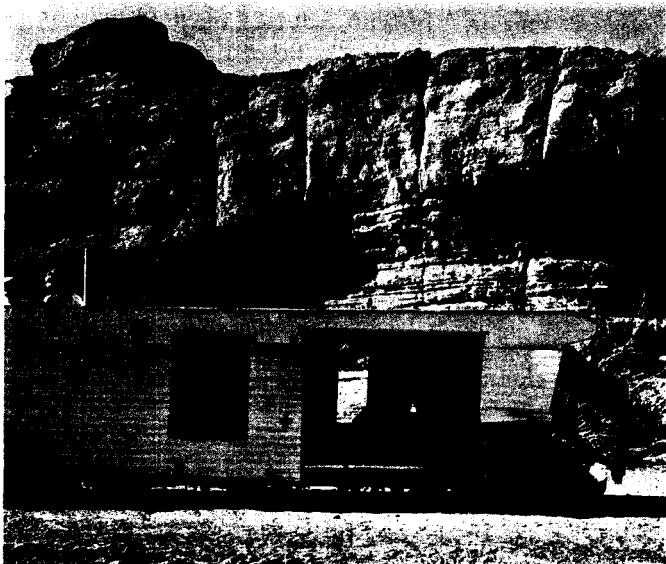
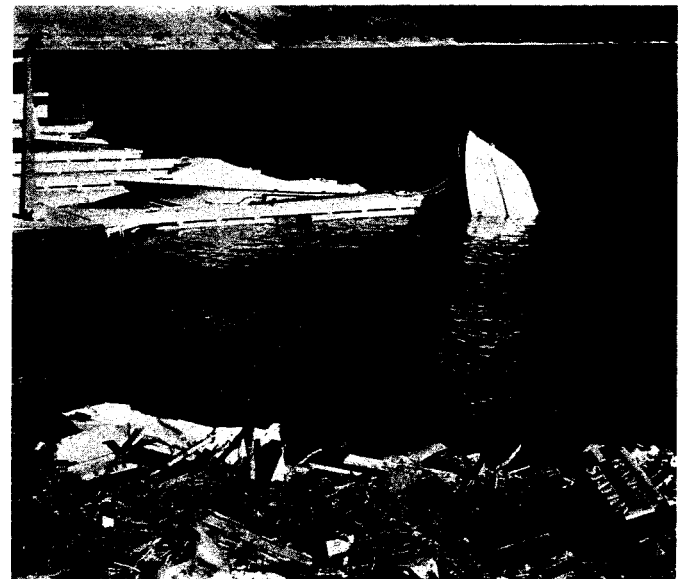
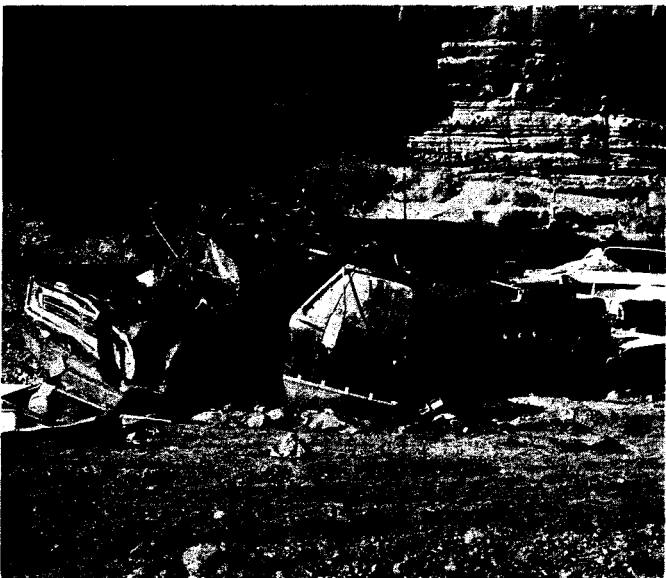
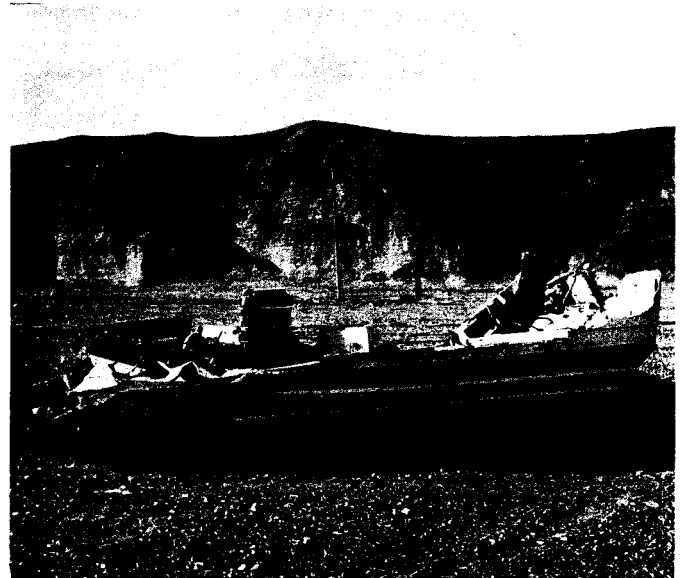
The restaurant was totally destroyed. Five trailer houses were totally destroyed, some have not been found, and a number of others were seriously damaged. Nine cabins near the base of the north canyon wall were destroyed, and 38 vehicles and 19 boat trailers were lost. Twenty-four boat-docking slips were obliterated and 23 boats were lost. Figure 12 shows changes to the boat

FIGURE 1.—Flood-damaged trailer, truck, and boats.

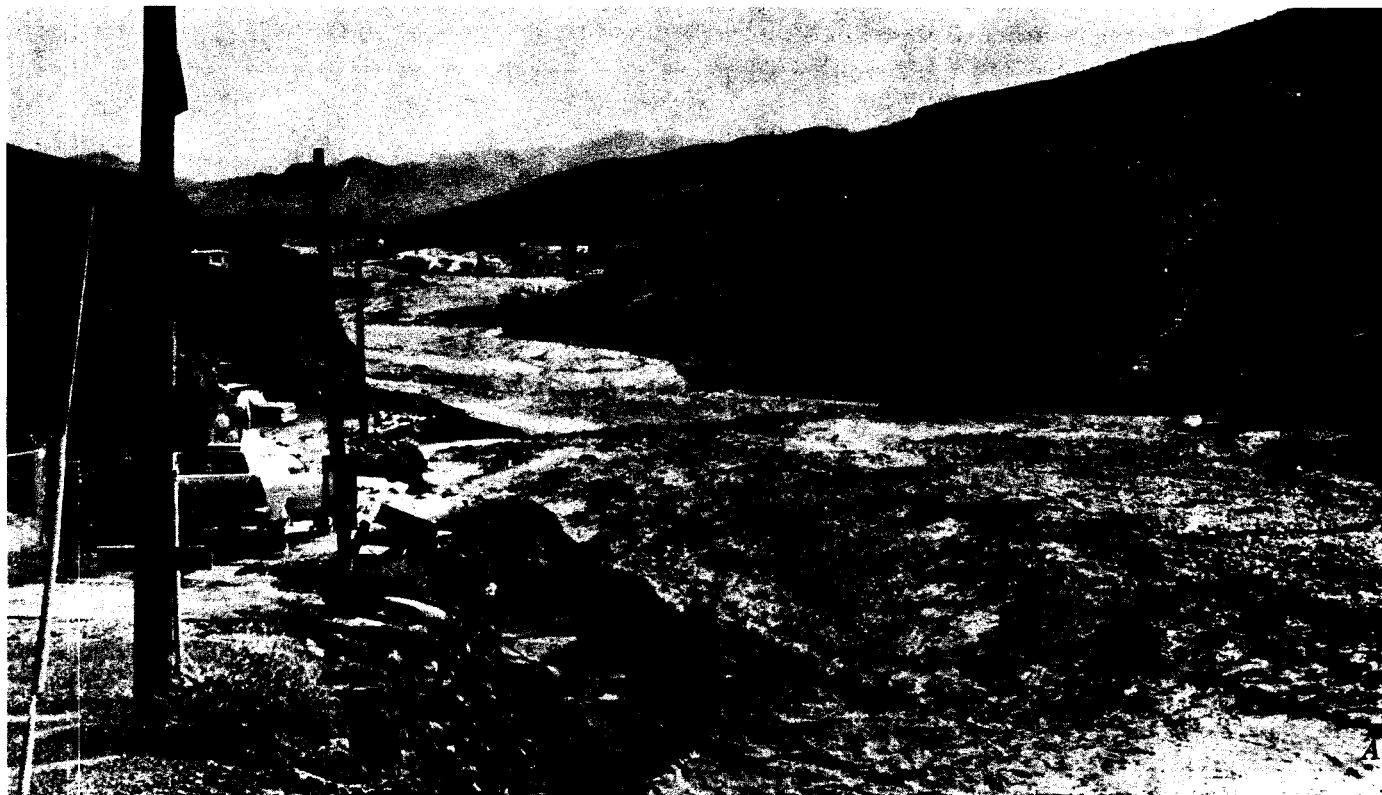
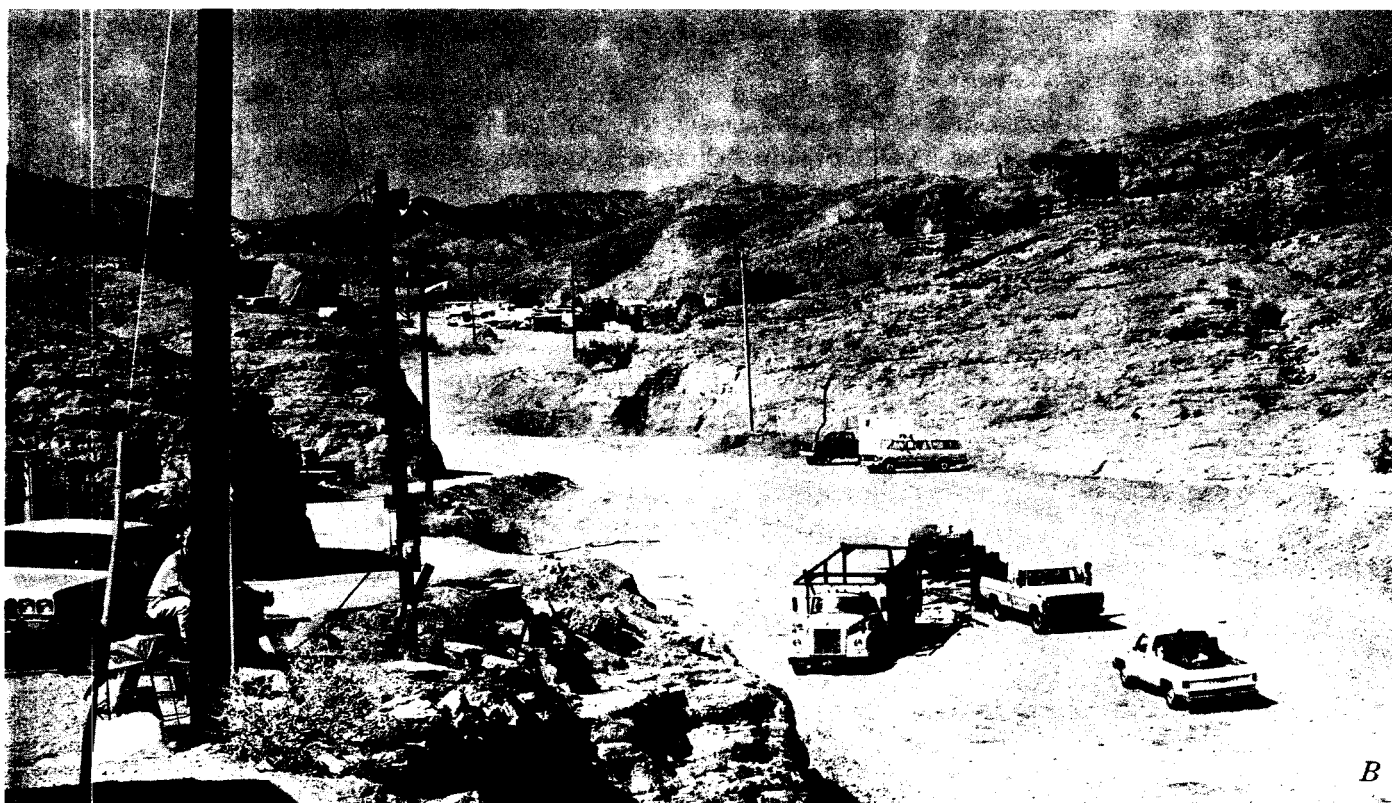
FIGURE 7.—Mouth of Eldorado Canyon. *A*, On September 14, 1974, probably during the late recession of flooding (photograph by Kenneth E. Beales, Las Vegas, Nevada). *B*, On October 1 during excavation of flood sediment deposits.

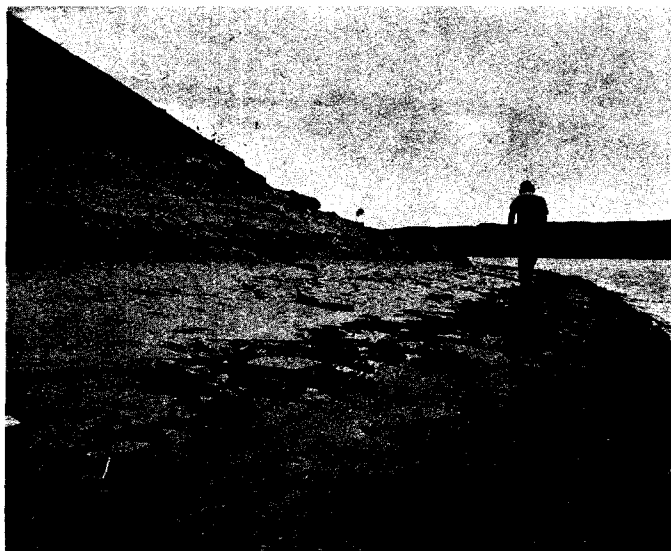
J. P. Monis and P. A. Glancy, U.S. Geological Survey, reconnoitered the east shore of Lake Mohave on September 19, 1974, for evidence of wave action caused by the flood surges entering the lake. Figure 8 shows the best noted evidence of possible flood wave action, at the base of a large sand dune across Lake Mohave about half a mile east and slightly south of the Eldorado Canyon mouth. The dune and its location relative to Eldorado Canyon are shown in the upper right part of figure 15. The horizontal cut in the sand above the flood debris (fig. 8), that was deposited before the lake was purposely drawn down to aid search-and-rescue operations, suggests a maximum wave height of about 1 3/4 ft. However, the horizontal cut may have originated from a higher pre-flood lake stand. In any event, no known evidence was observed of flood wave action greater than about 1 3/4 ft.

FIGURE 8.—Wave-cut bench (above debris line) along east shore of Lake Mohave, possibly caused by flood surges entering the lake.

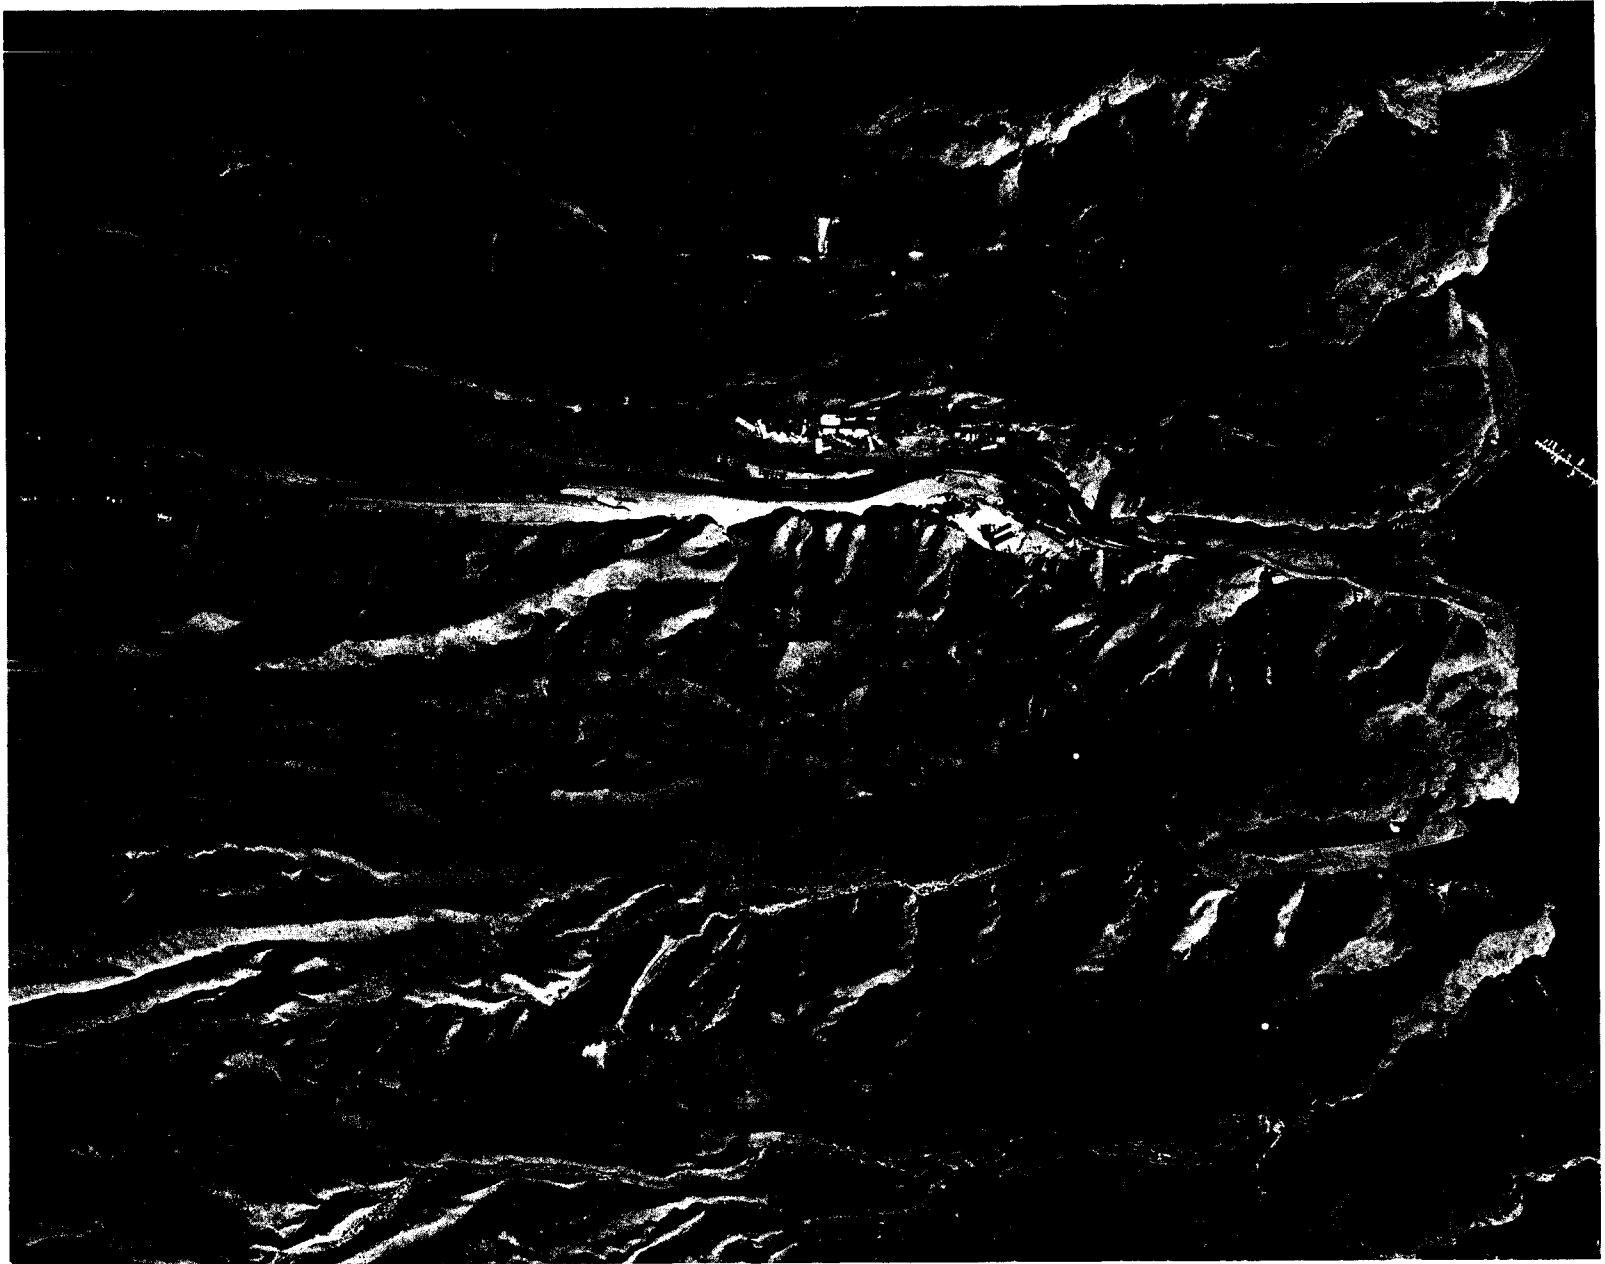
FIGURE 10.—Vertical aerial photo of the terminal reach of Eldorado Canyon drainage and adjacent drainages on September 20, 1974. Photograph courtesy of Nevada Division of Highways.

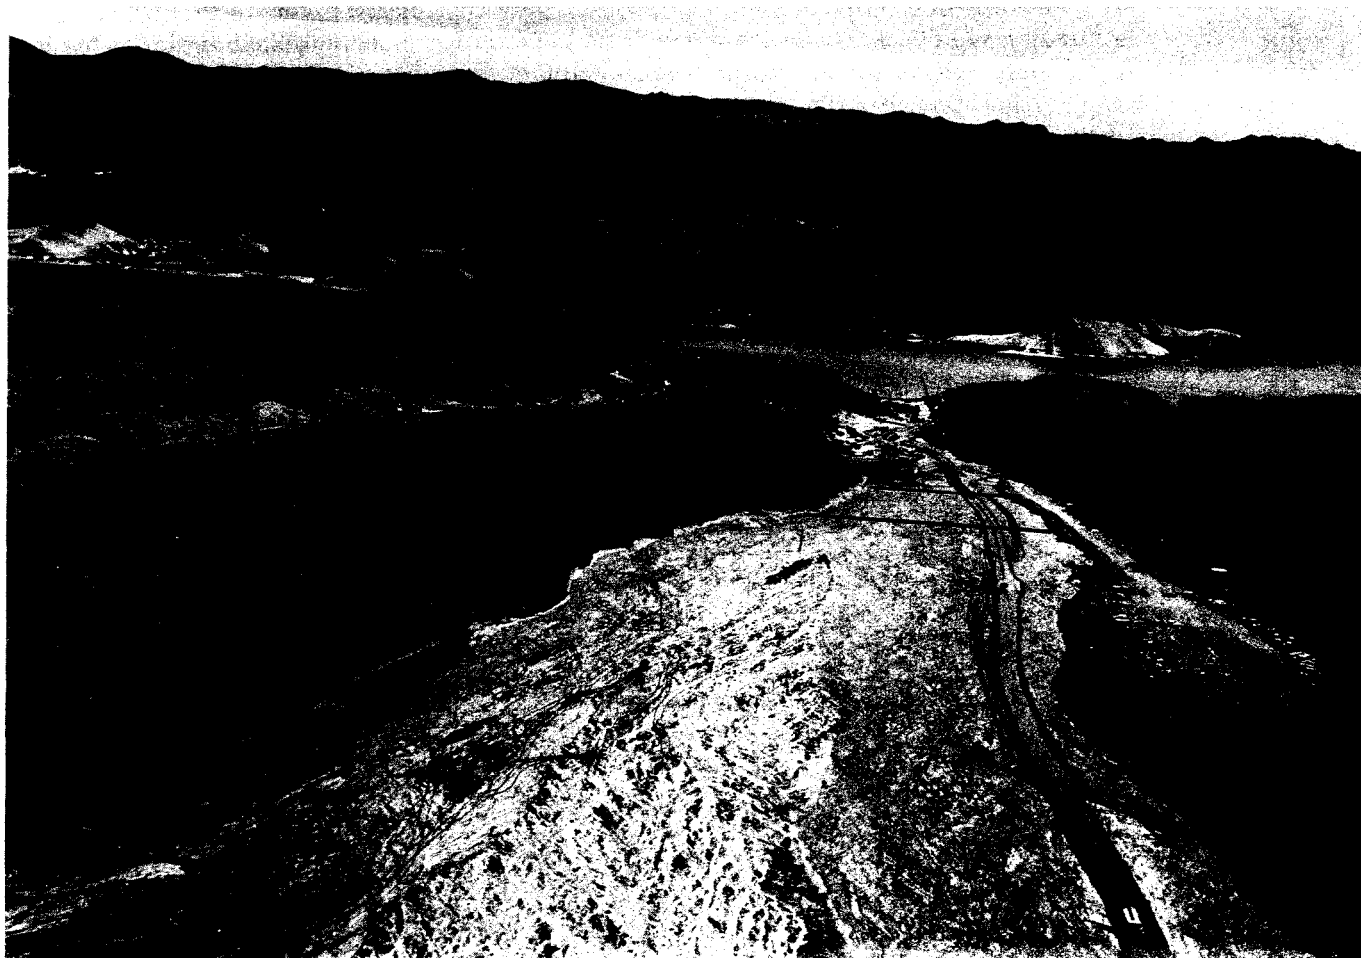
Figures 12, 13, and 14 show locations of flood boundaries, high-water profiles, streambed profiles, and a qualitative assessment of damage to some cultural features in Eldorado Canyon. Figure 15 shows the general flood plain extent and characteristics just above the developed area. The average slope of the profiles in the measured reach (fig. 12) is 280 ft/mi. The left-bank profile through the trailer park area indicates a 2- to 4-ft depth of water above the canyon floor (figs. 14 and 16), whereas the right-bank profile in the same section is defined by one piece of debris found on the vertical wall about 16 ft above the canyon floor. Assuming that this piece of debris actually represents the true water surface along the right bank, the difference in left- and right-bank elevations must be explained by the sloshing of water from bank to bank (figs. 12, 7A), and by local pileup of water caused by cars and boat trailers in the parking area. Downstream from the trailer parking area (fig. 14), the left- and right-bank profiles become very erratic and indicate water pileup due to the contraction of the reach. The momentum of the flowing water forced the water up and over the projecting bed-rock ridges. The profiles (fig. 14) show that the water surface along the left bank was as much as about 25 ft above the canyon floor where the flow was pushed up and over the projecting rock ridge. Figure 16 shows the contrast between trailers caught within the left-bank high water line (damaged) and those on slightly higher ground (undamaged).

FIGURE 15.—Downstream (eastward) aerial photograph of Eldorado Canyon terminus taken September 17, 1974. Boat storage area to right. Horizontal lines show approximate slope-area site.

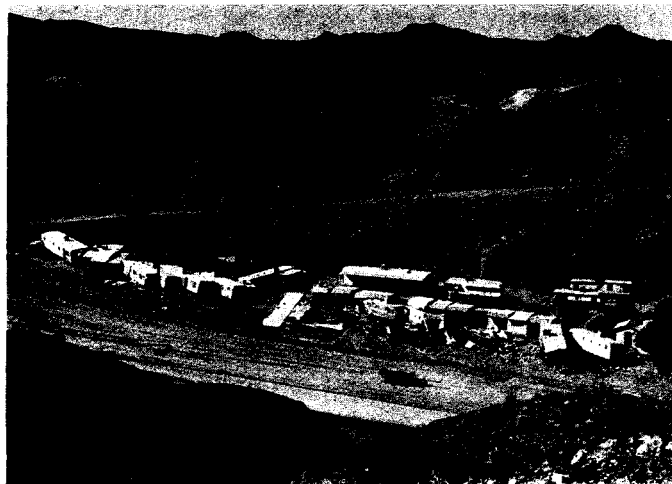
FIGURE 16.—Heavily damaged trailer park at Eldorado Canyon Resort. Afternoon, September 19, 1974.

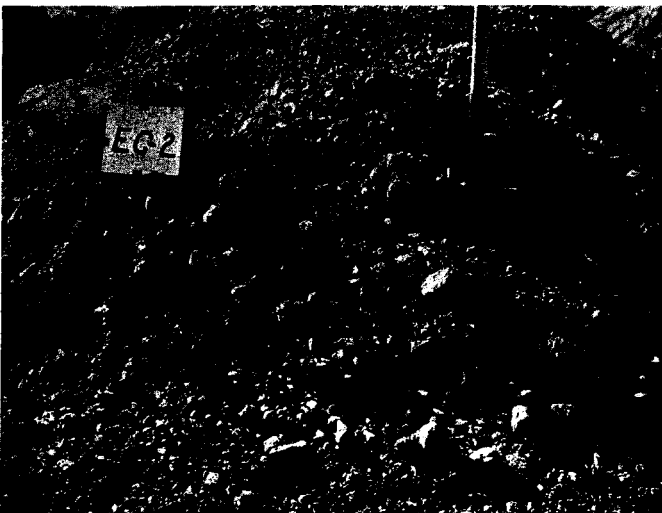
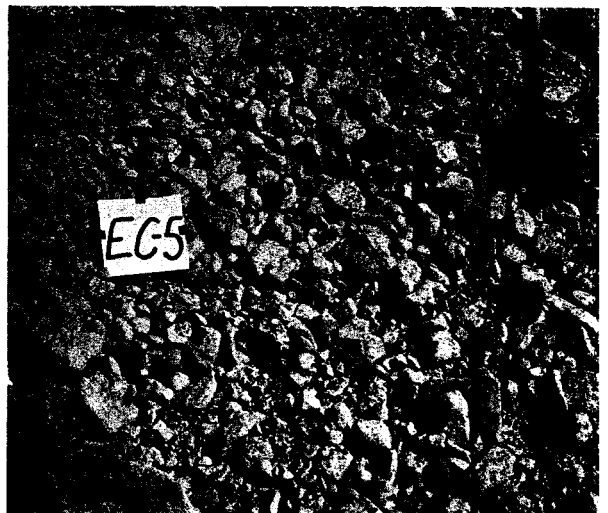
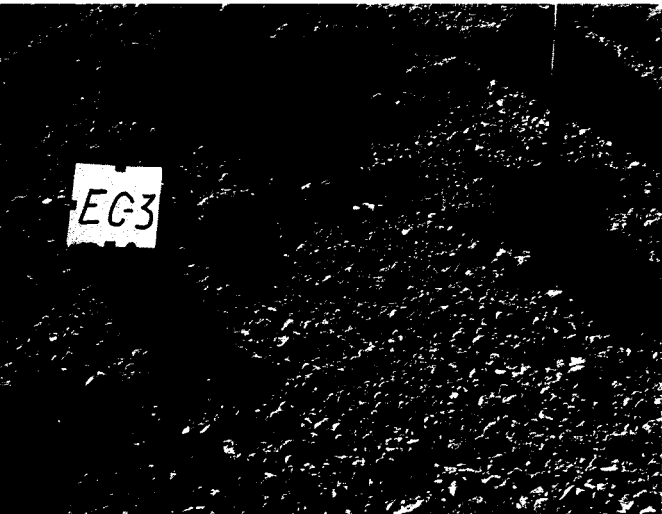
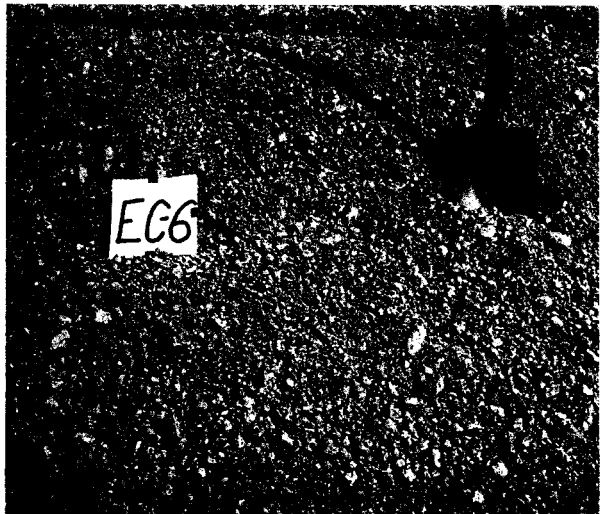
FIGURE 18.—Excavated sediments quantitatively described in table 5.

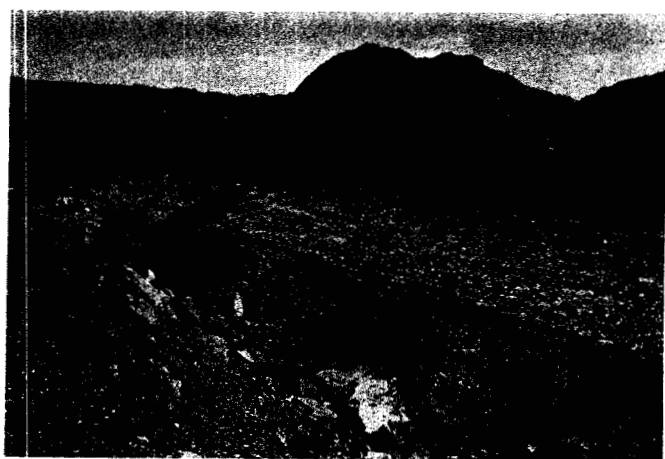
FIGURE 21.—Downstream view of boulder deposits that probably moved on September 14 in Techatticup Wash.

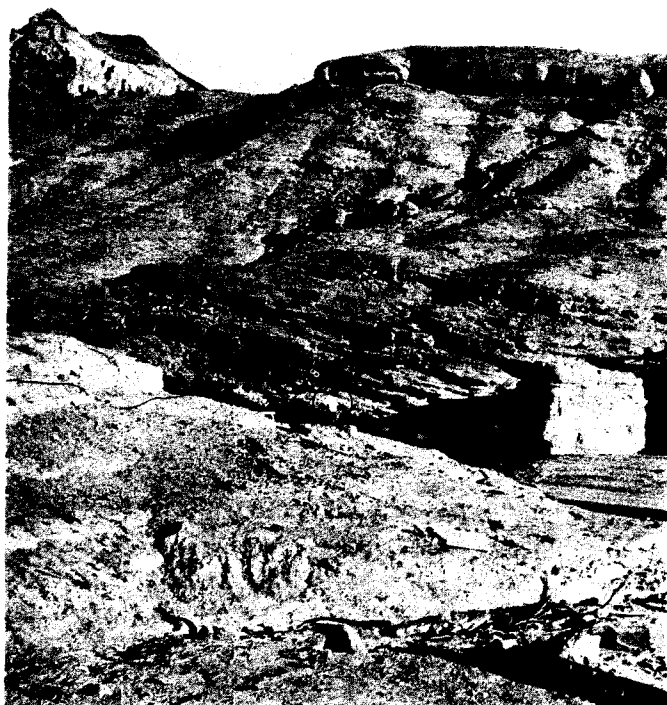
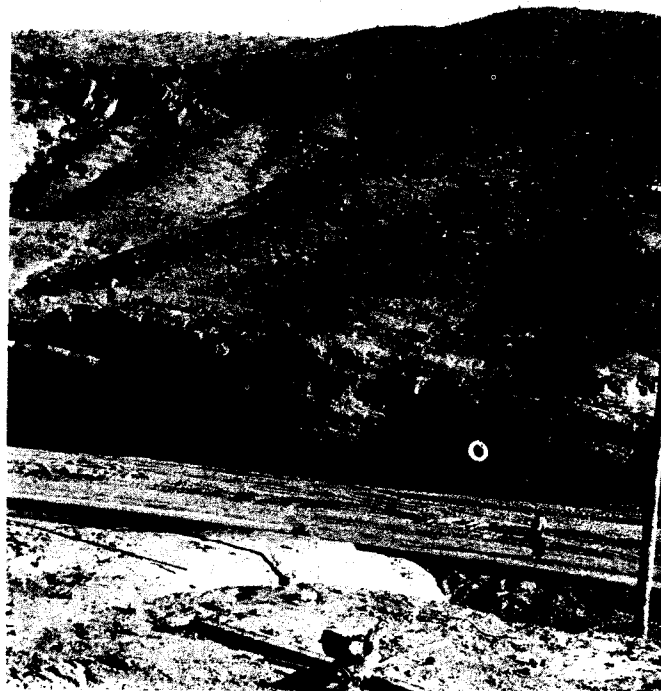
Figure 23 shows the location of high water lines just upstream from the coffee shop site, where the canyon narrows abruptly. Flow depths at this point, approximately where the oncoming surge of water was observed

FIGURE 23.—Position of high water line at canyon narrows just upstream from former restaurant. Note people standing on high water line for scale.

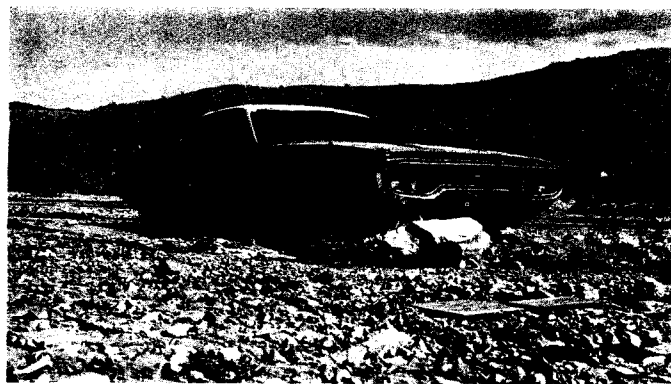
Flow surges continued and added to the stream stage until Sessums' car was swept downstream about a mile. It was subsequently deposited on the floor of the wash by the receding streamflow. Figure 24 pictures Sessums' car on the afternoon of September 20 at its final resting place. The boulder deposited in front of the car was discussed earlier (p. 16). The car paint was unscratched in spite of the fact the car was partly inundated by rapidly flowing turbulent water for a substantial period of time. The flow apparently did not abrade or damage the paint surface, nor were there any visible signs of damage by large moving rocks. This evidence suggests that sediment transport in Eagle Wash apparently was dominated by gravel-size bedload that passed beneath the painted surface of the auto. The apparent dominance of gravel-size sediment agrees with the particle-

FIGURE 24.—An automobile at rest in lower Eagle Wash after about a 1-mile transit in flood.

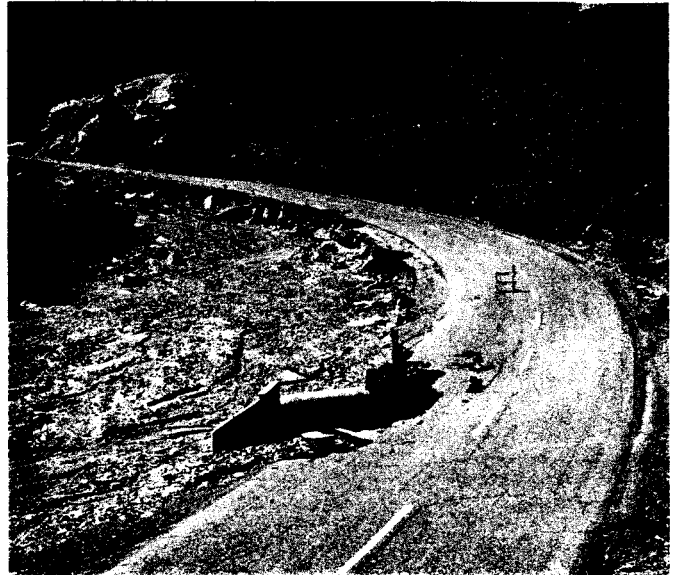
Severe lateral scour did occur in some places along major channels. Figure 27 shows examples of highway damage caused by this type of erosion.

FIGURE 27.—Highway damage in Techatticup Wash caused mainly by lateral channel scour.
