# **Record Flash Flood of July 8, 1999: Ten Year Anniversary**

**Chris Stachelski and Barry Pierce**

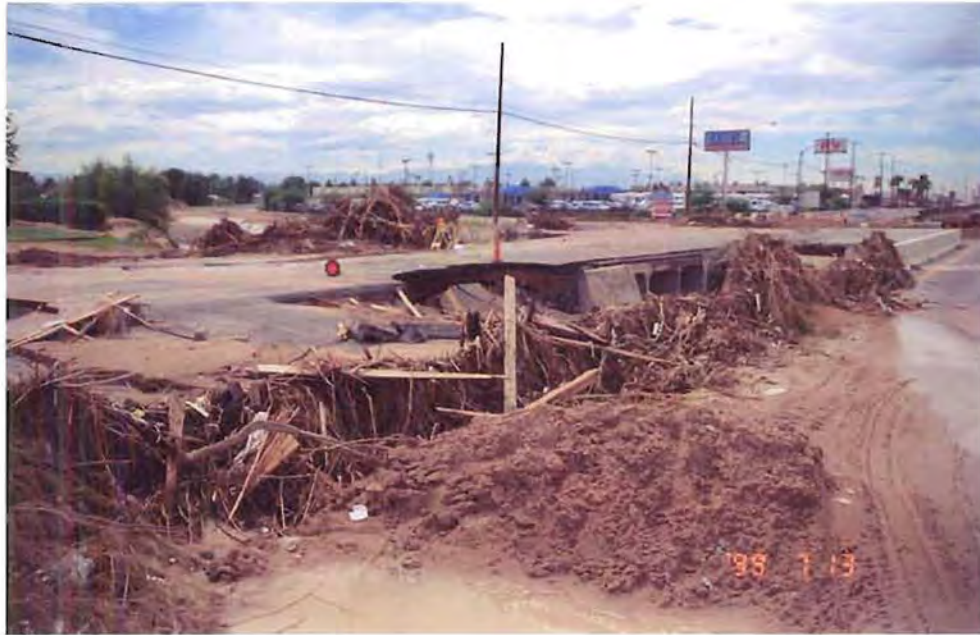
Figure 3 – Damage from the flood still remained several days later along Boulder Highway. Photo Courtesy Clark County Regional Flood Control District.

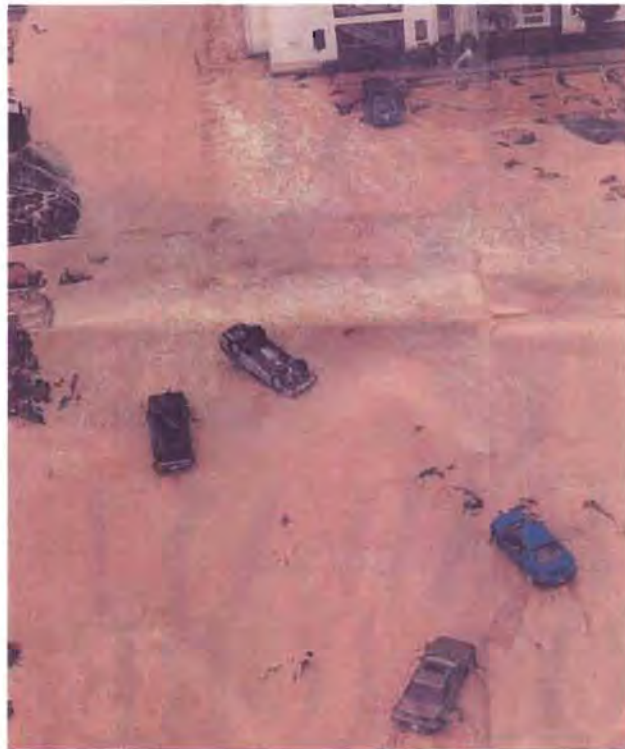
Figure 4 – Cars flipped by floodwaters near Boulder Highway and the Flamingo Wash. Photo Courtesy Las Vegas Review-Journal.

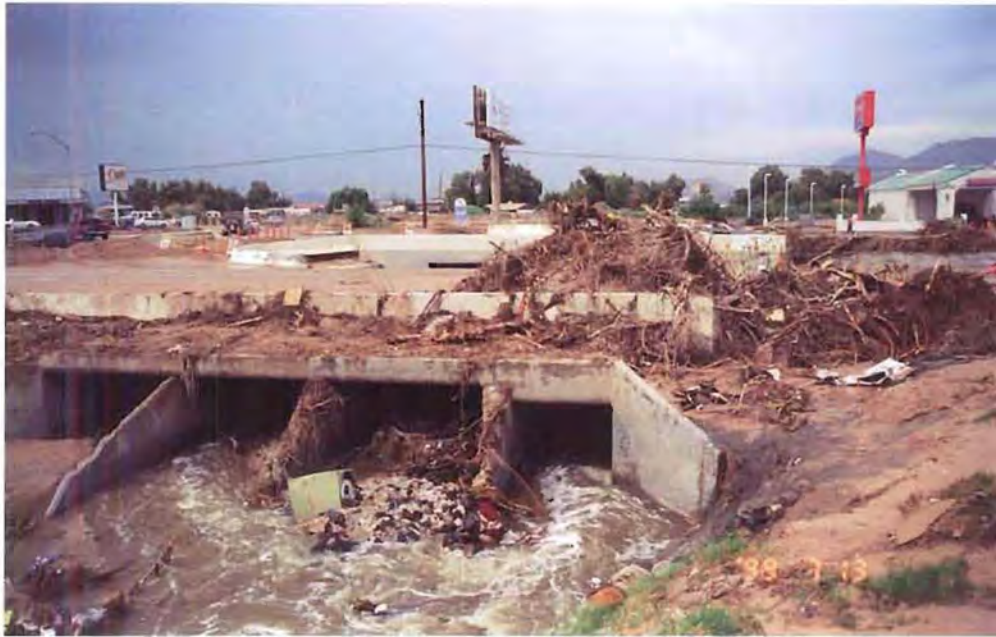
Figure 5 – Debris lining Boulder Highway after the storm. Photo Courtesy Clark County Regional Flood Control District.

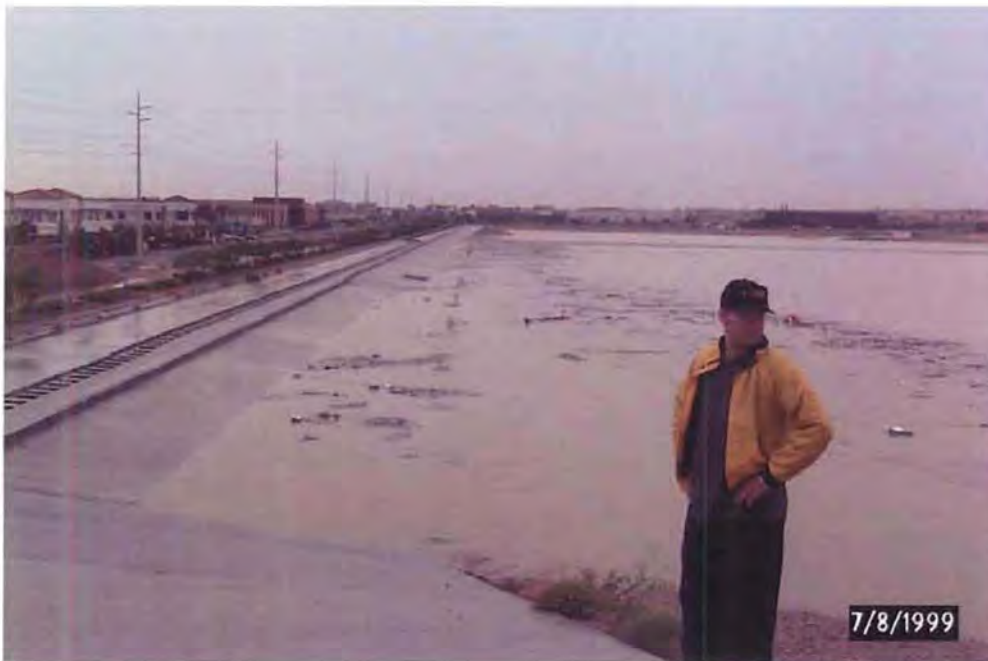
Figure 6 – The Gowan Detention Basin came within one foot of capacity, reaching a depth of 22 feet. Photo Courtesy Clark County Regional Flood Control District.
