Rainfall & Flood Event Report

September 11, 2012

prepared by
Timothy E. Sutko
Environmental Mitigation Manager
Clark County Regional Flood Control District

A Preliminary Summary Of The September 11, 2012 Las Vegas Valley Heavy Rain And Flash Flood Event

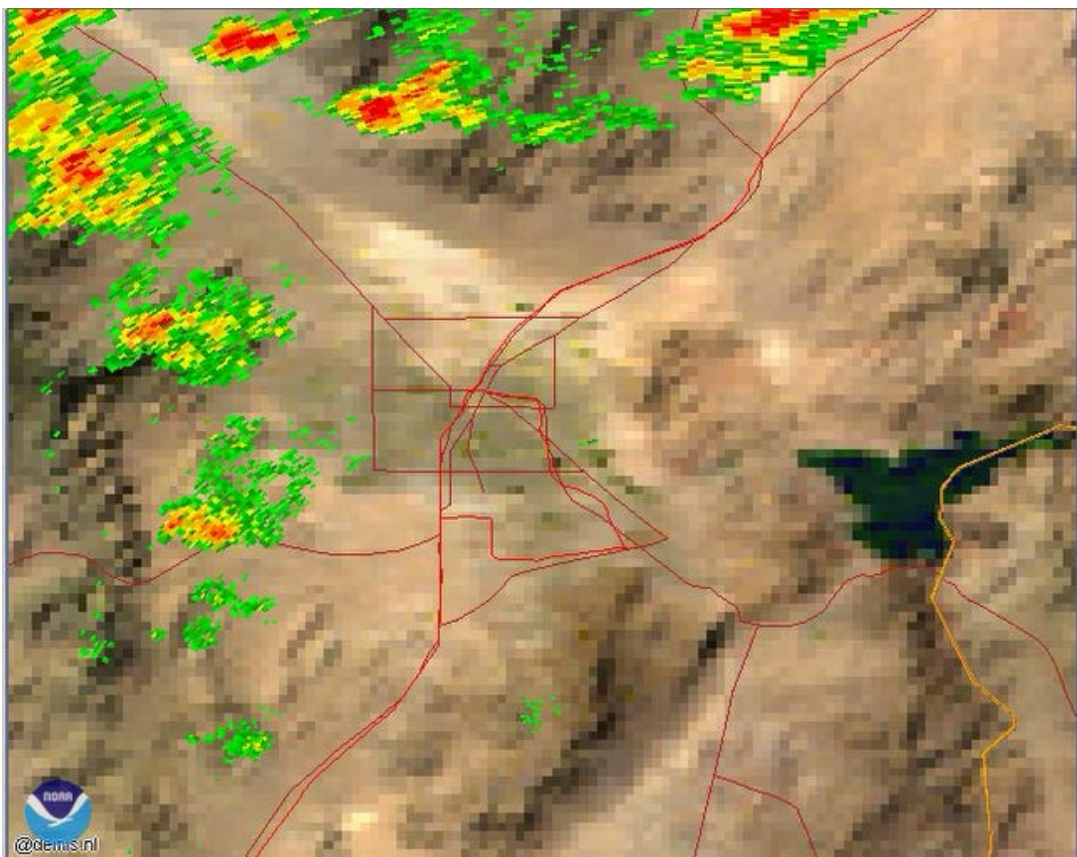
Figure 1. KESX radar reflectivity at 12:04 PM September 11, 2012

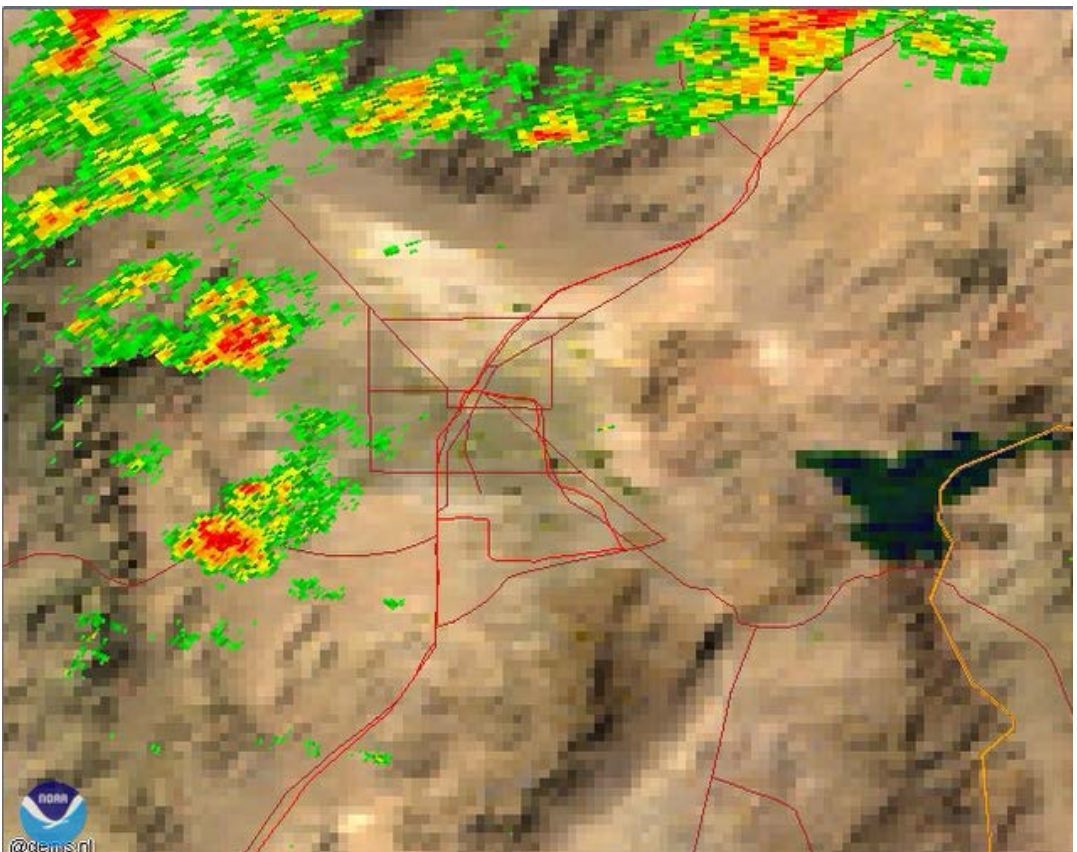
Figure 2. KESX radar reflectivity at 12:21 PM September 11, 2012

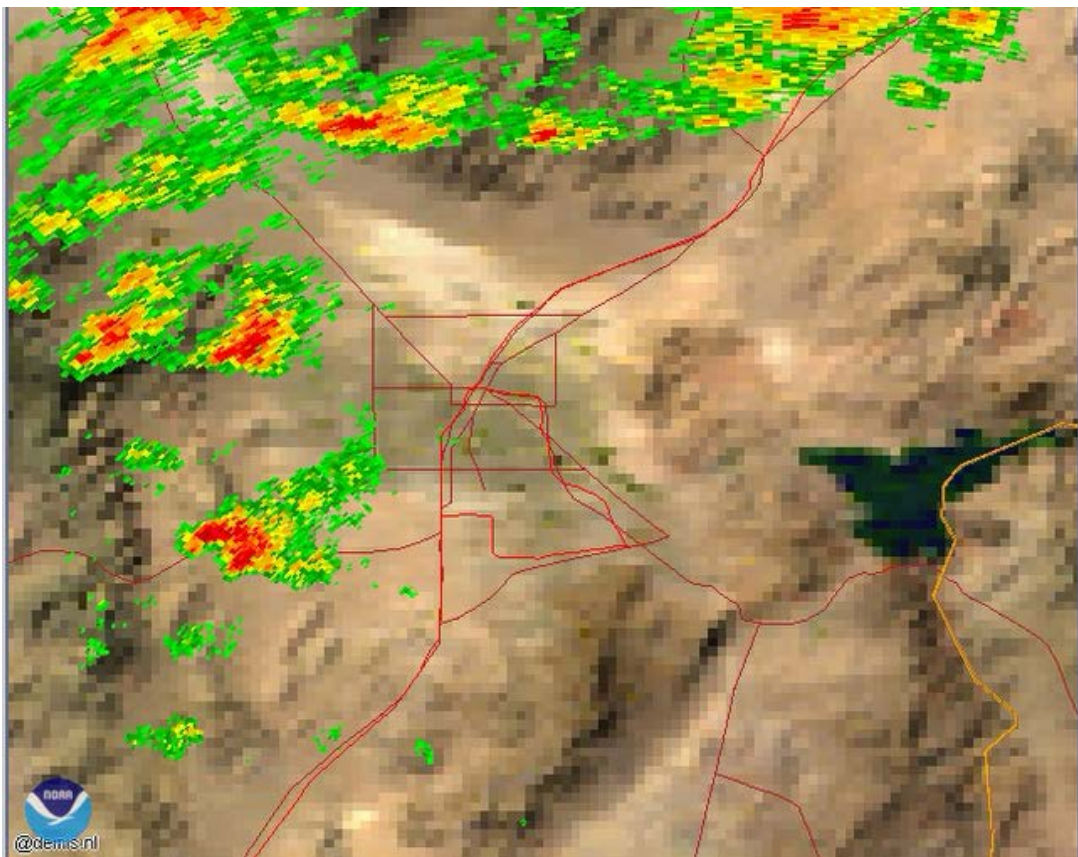
Figure 3. KESX radar reflectivity at 12:30 PM September 11, 2012

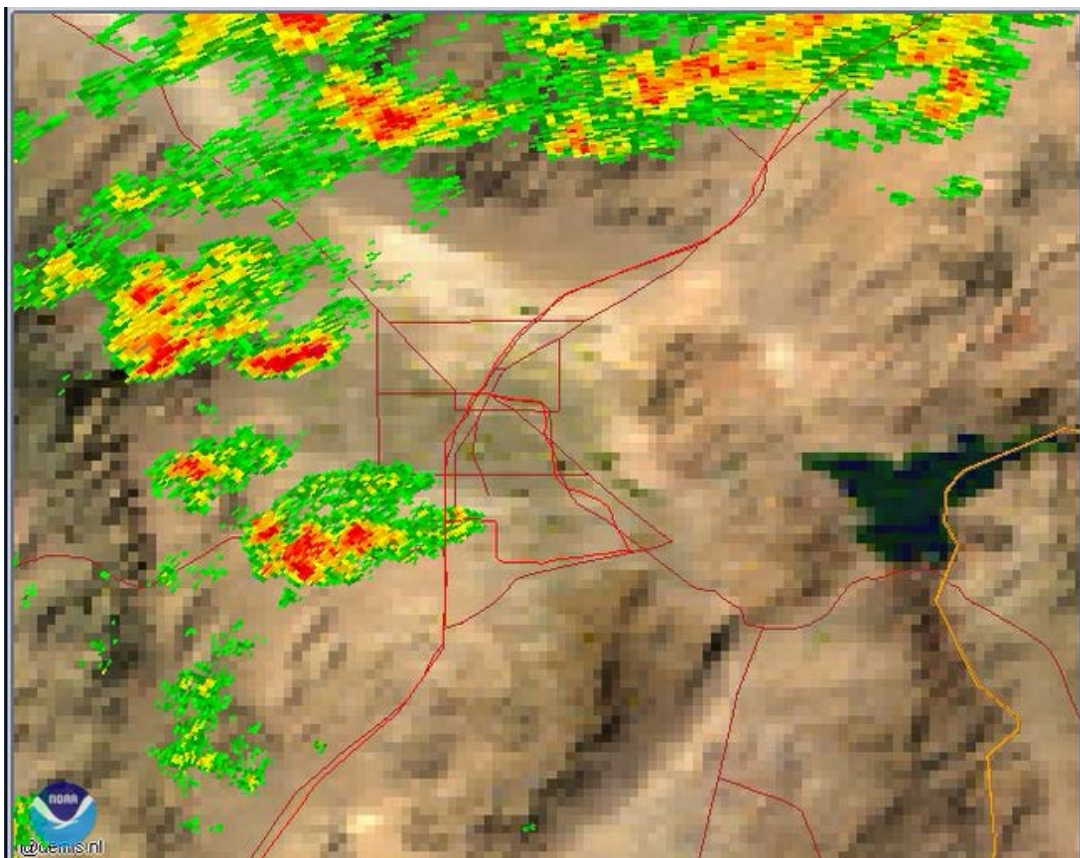
Figure 4. KESX radar reflectivity at 12:47 PM September 11, 2012

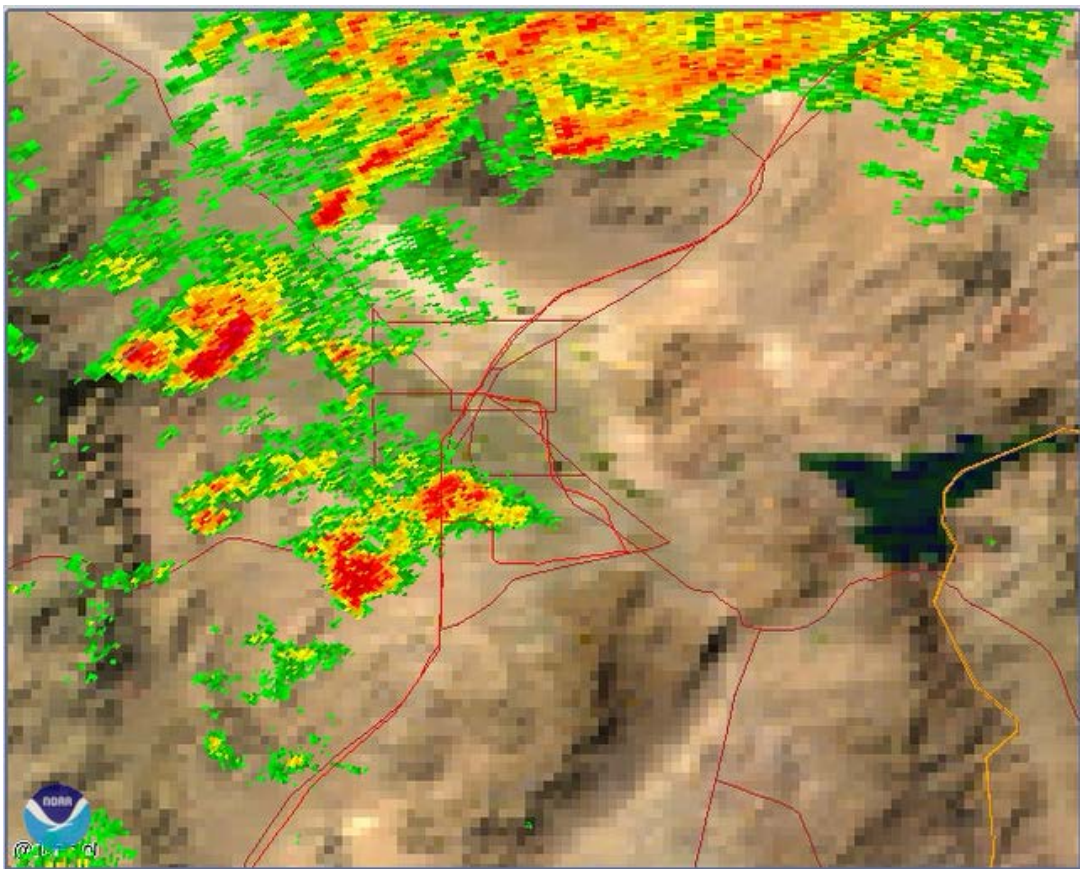
Figure 5. KESX radar reflectivity at 1:05 PM September 11, 2012

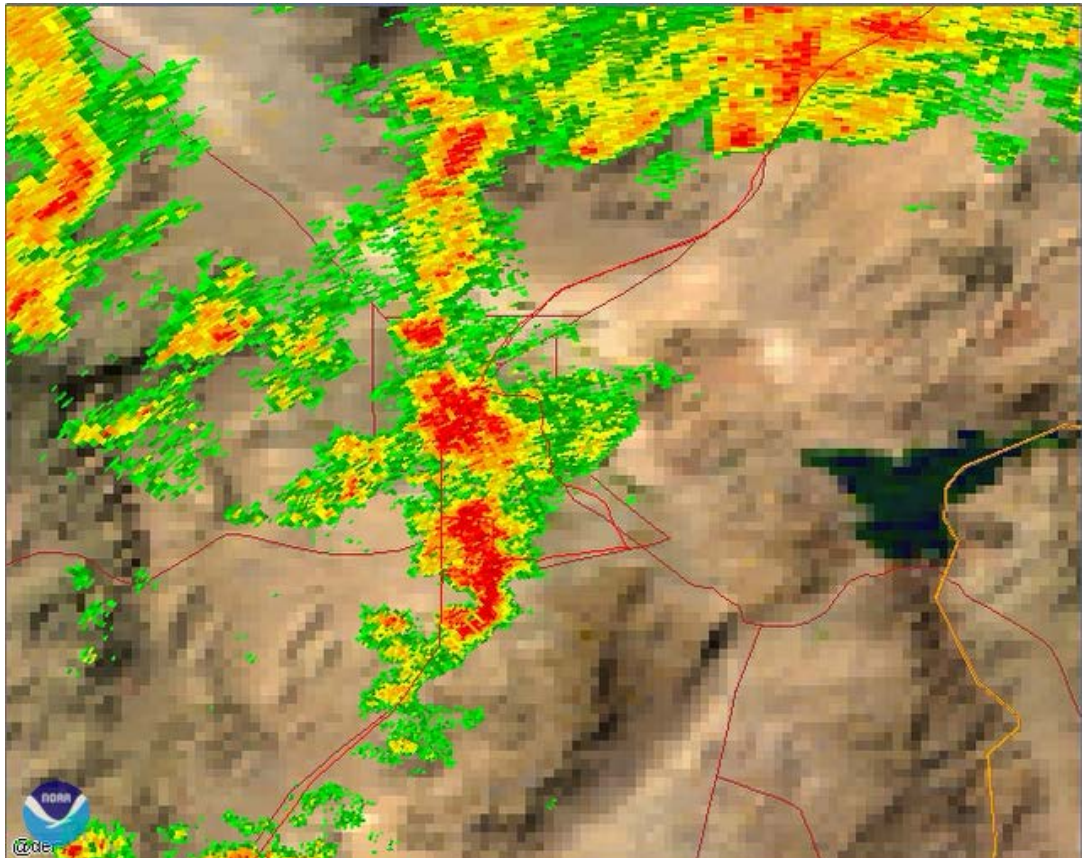
Figure 6. KESX radar reflectivity at 1:30 PM September 11, 2012

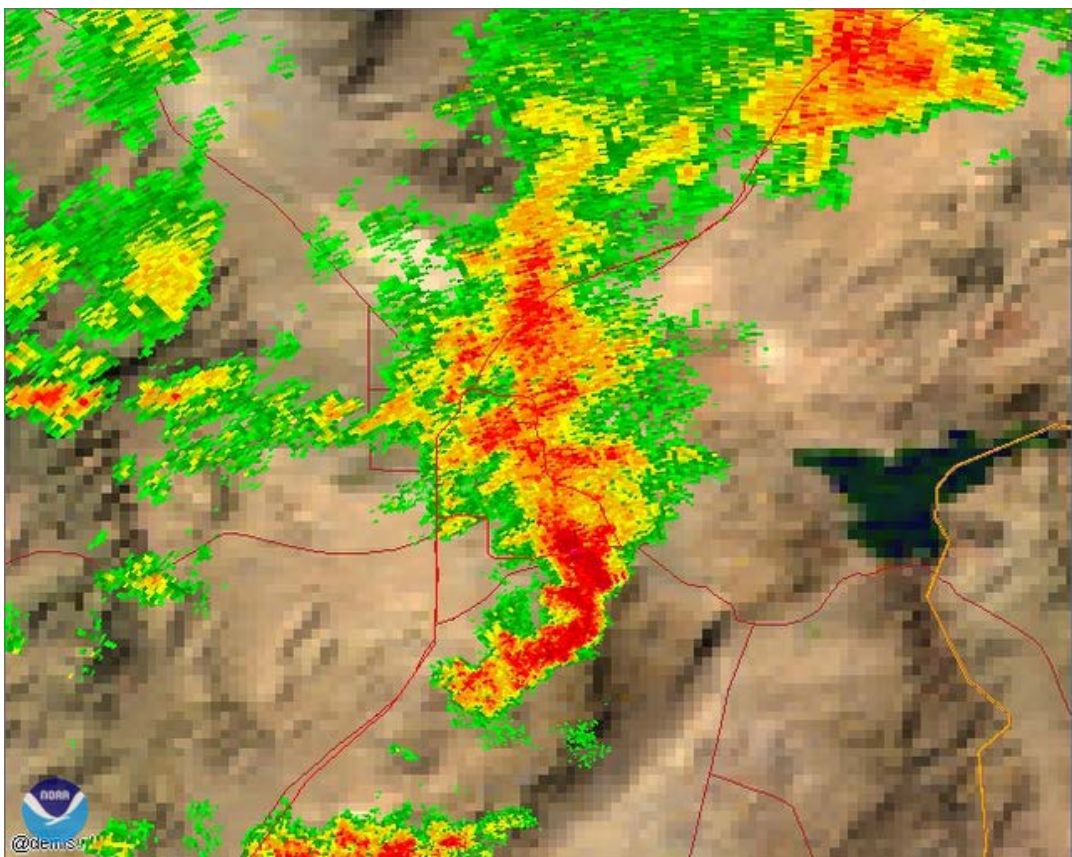
Figure 7. KESX radar reflectivity at 1:52 PM September 11, 2012

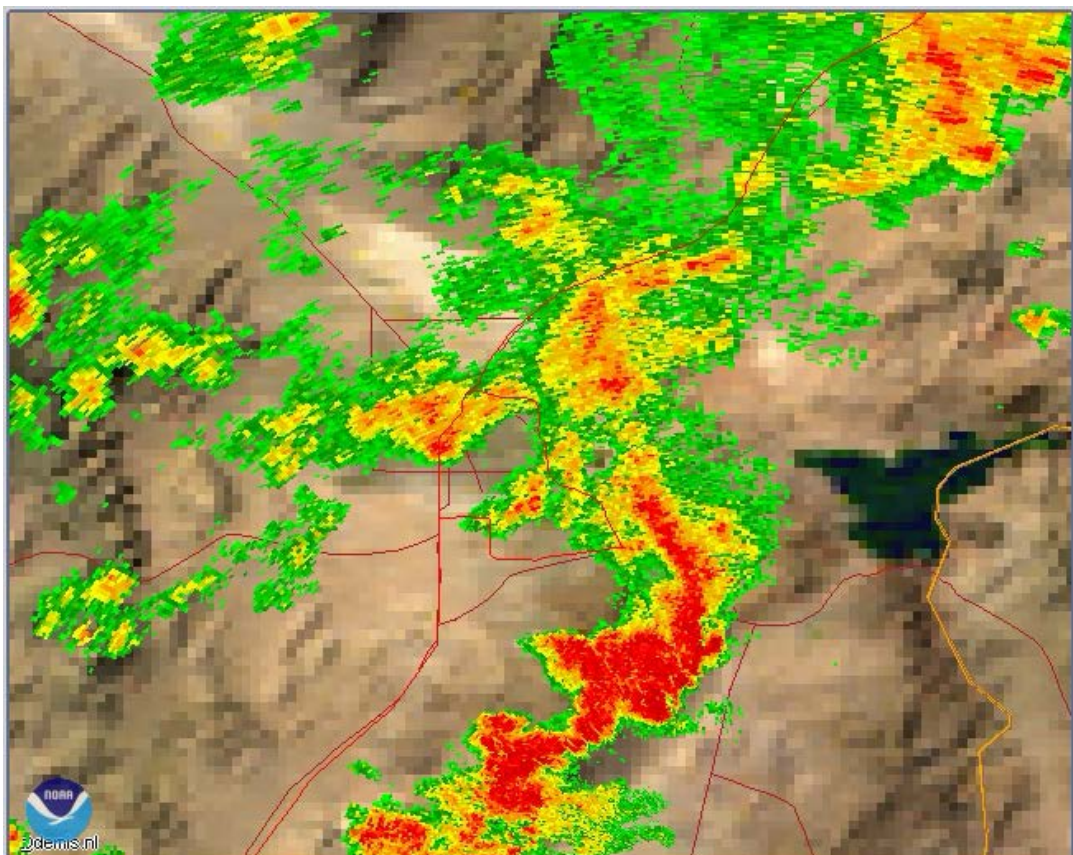
Figure 8. KESX radar reflectivity at 2:14 PM September 11, 2012

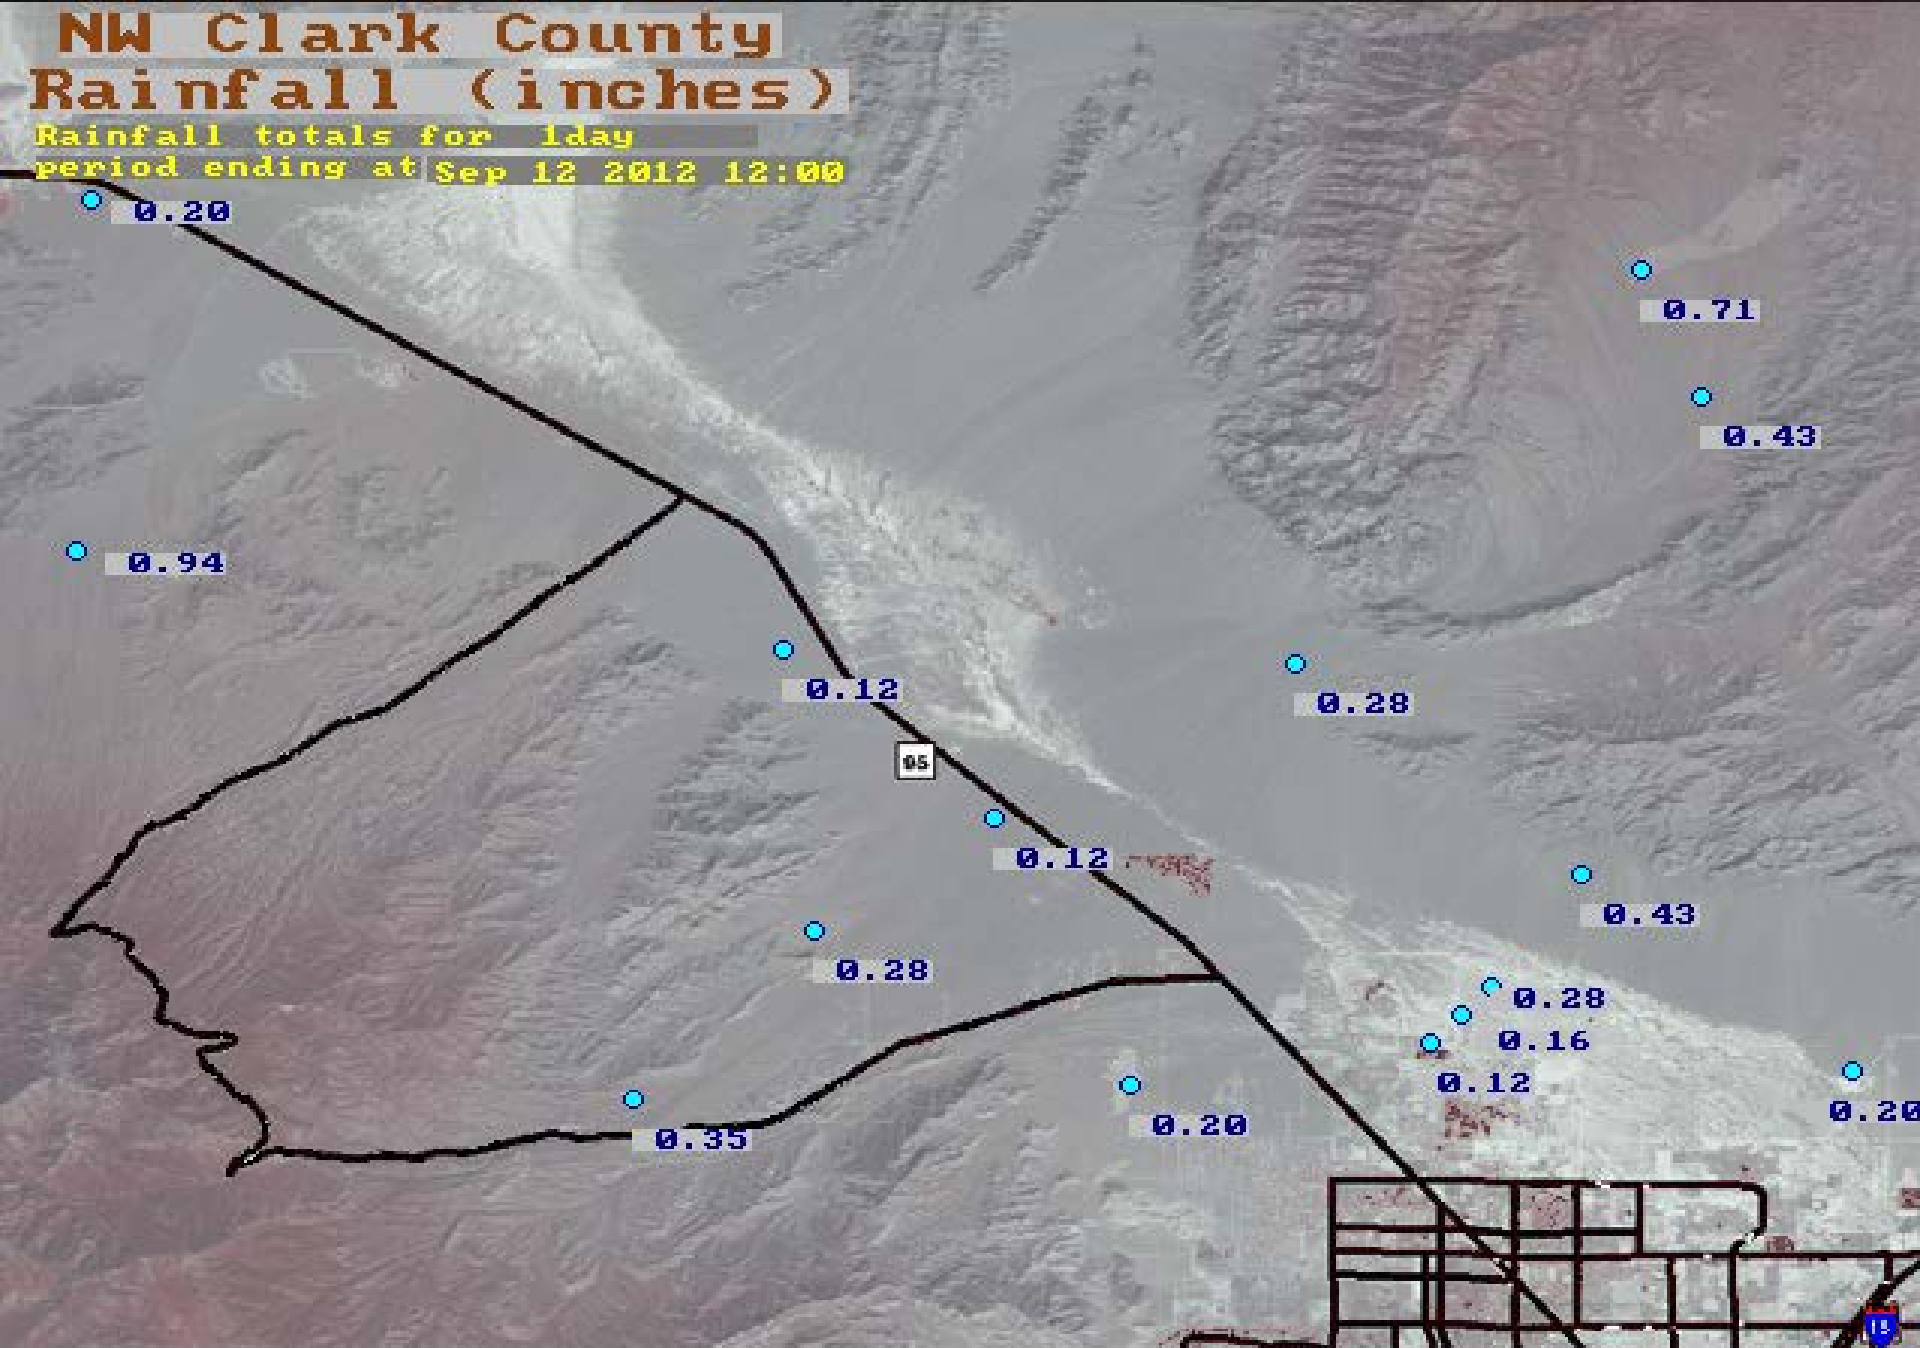
Figure 16. September 11, 2012 - 1 day rainfall totals NW Clark County (RFCDFTRS)

During this event, seventeen FTRS rain gages in the Las Vegas Valley measured at least 1 inch of rain, most of which occurred in less than 2 hours. Tables 1 & 2 present representative data on the rainfall and rainfall intensities measured by the FTRS gages. Figures 9-17 present the 24-hour rainfall totals throughout Clark County as reported by the FTRS.

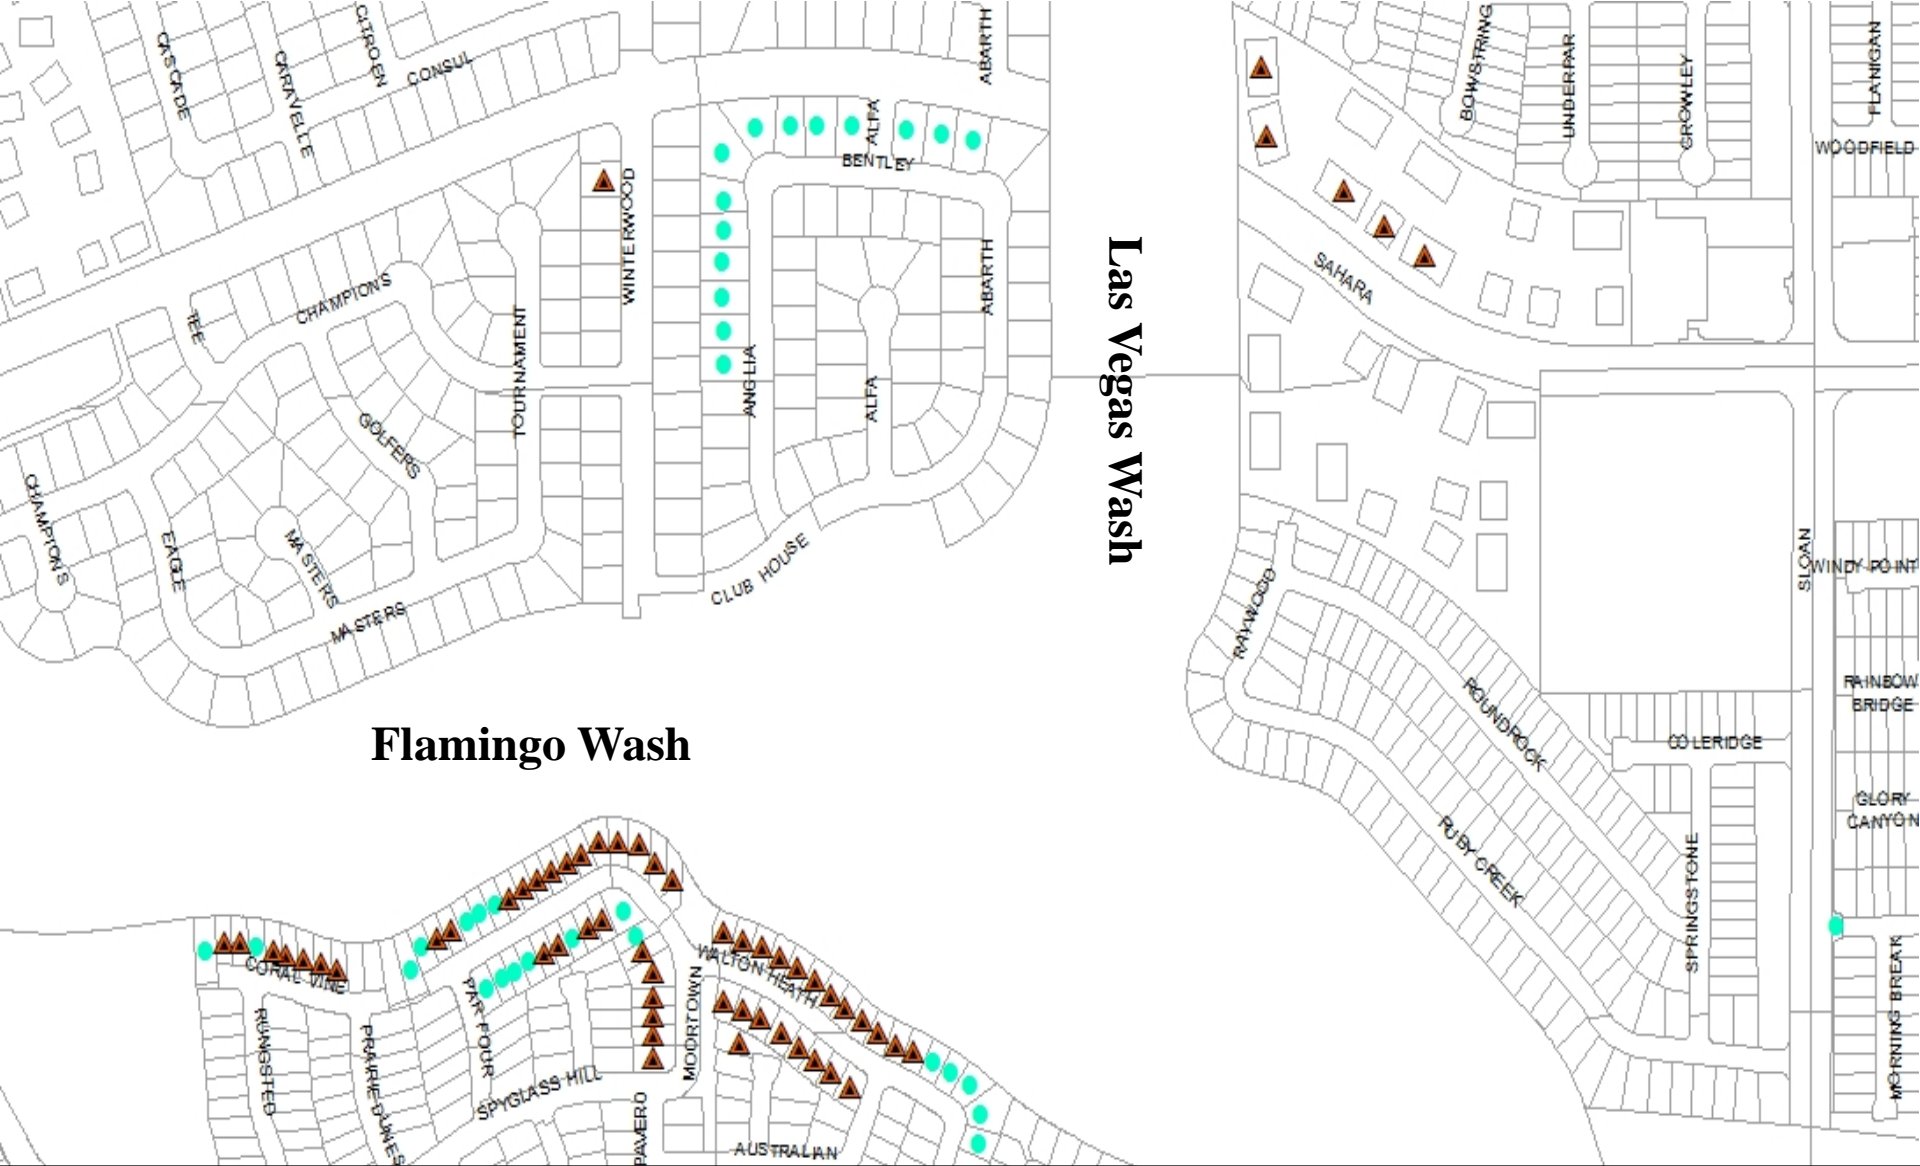
Figure 18. Properties in Desert Rose Golf Course area inspected (cyan dot) and/or suffering interior/structural damages (brown triangle), September 11, 2012 (source, CCOEM)

There was extensive flooding of roadways and residences in sub-divisions located adjacent to the Desert Rose Golf Course, through which both the Las Vegas Wash and Flamingo Wash flow. There were at least 60 instances of flood damage to property reported in this area. In addition, the media has reported that there were more than 20 incidents of stranded drivers needing assistance after their vehicles were inundated by flood flows. Buildings which experienced interior and/or structural damages in this area are identified in Figure 18.

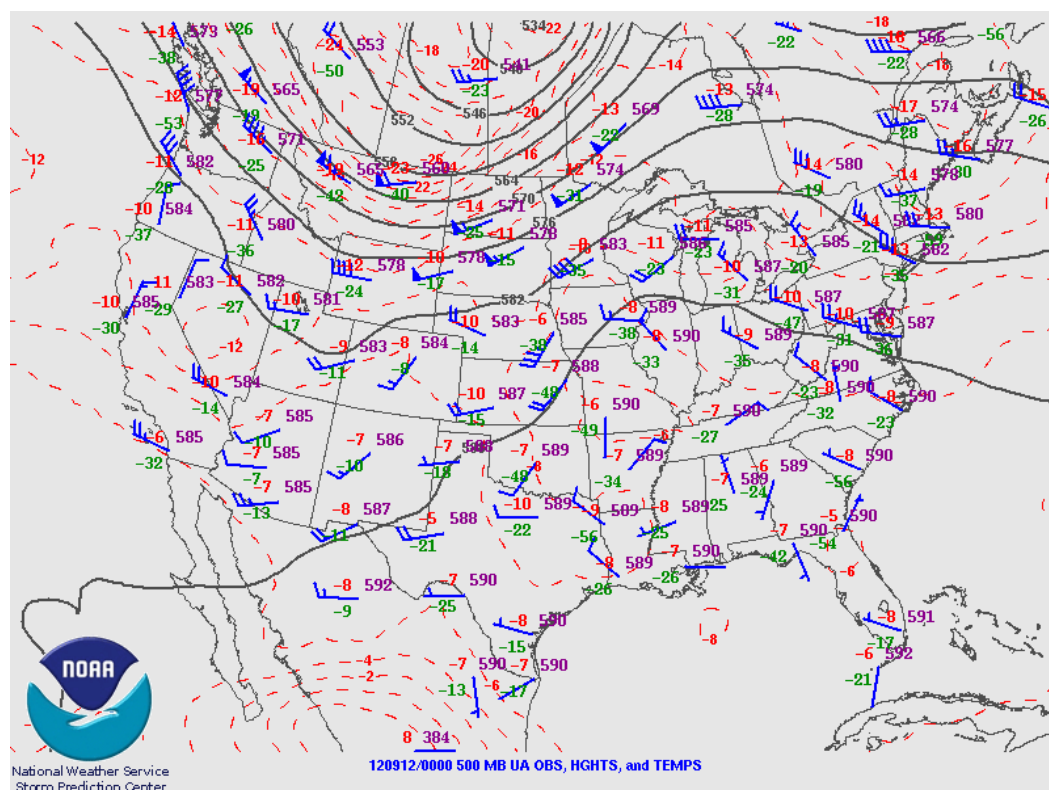
Upper air charts showing the observed values at 500 mb at 12Z on September 11, 2012 (top) and 00Z on September 12, 2012 (bottom). Blue wind barbs can be noted on both maps while solid black lines indicate height lines. Maps courtesy Storm Prediction Center.

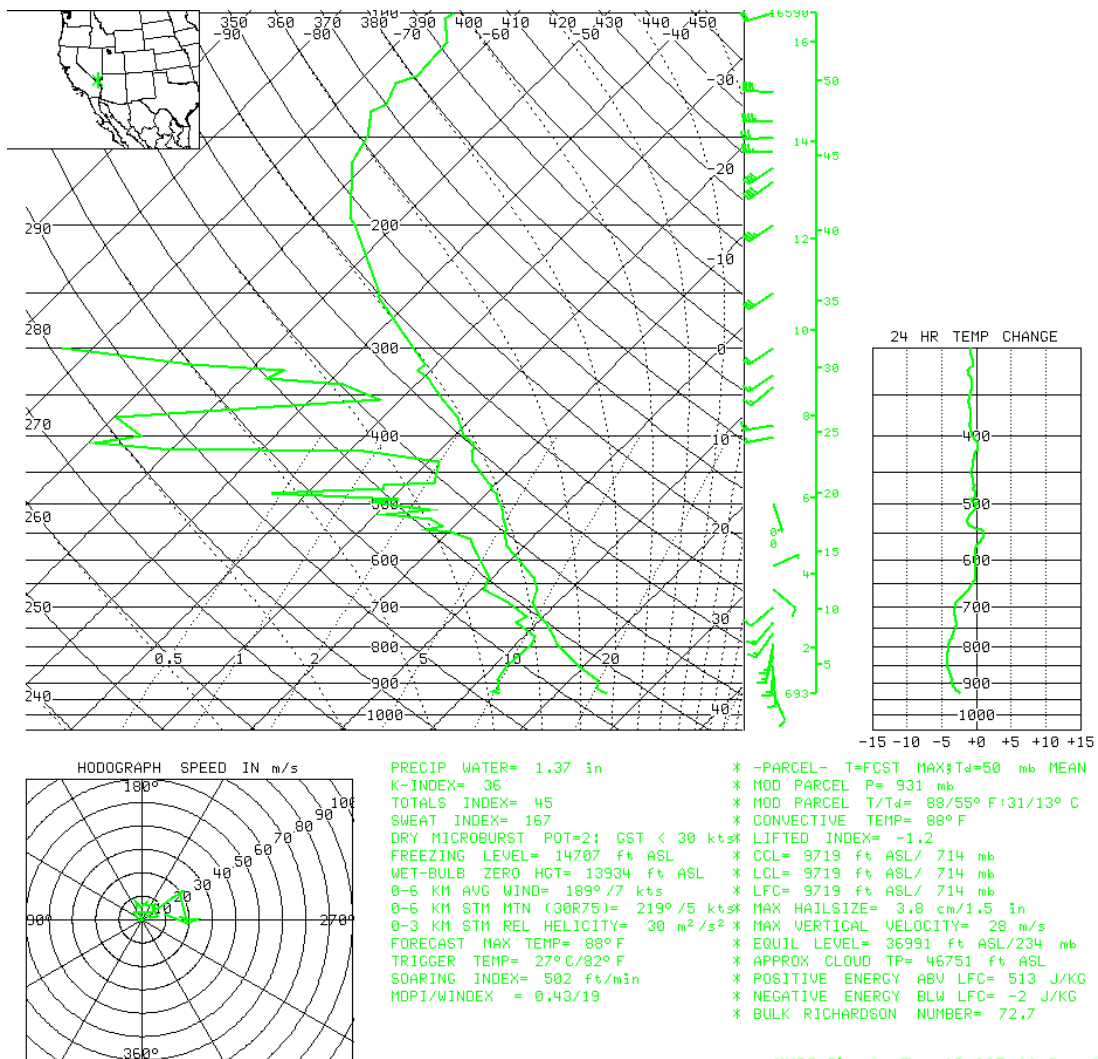
KVFF Skewt Tue 12:00Z 11-Sep-12
 12Z sounding from Las Vegas, Nevada on September 11, 2012.

An area of low pressure was noted over central California in the mid and upper levels at 12Z on September 11th. Ahead of this low, exceptionally moist and unstable air existed over the Mojave Desert and southern Great Basin. The 12Z radiosonde launched from Las Vegas measured a precipitable water value of 1.37 inches and an 850 mb dewpoint of 11 degrees Celsius indicative of an extremely moist air mass. Precipitable water values over an inch and 850 dewpoints at or above 8 degrees Celsius are usually indicative of an atmosphere conducive to flash flooding in the Mojave Desert based on local rules of thumb. The combination of the enhanced lift from the low and a very moist atmosphere produced a set-up favorable for thunderstorms producing heavy rain. The low moved across southern Nevada between 19Z and 23Z with showers and thunderstorms ahead of it.

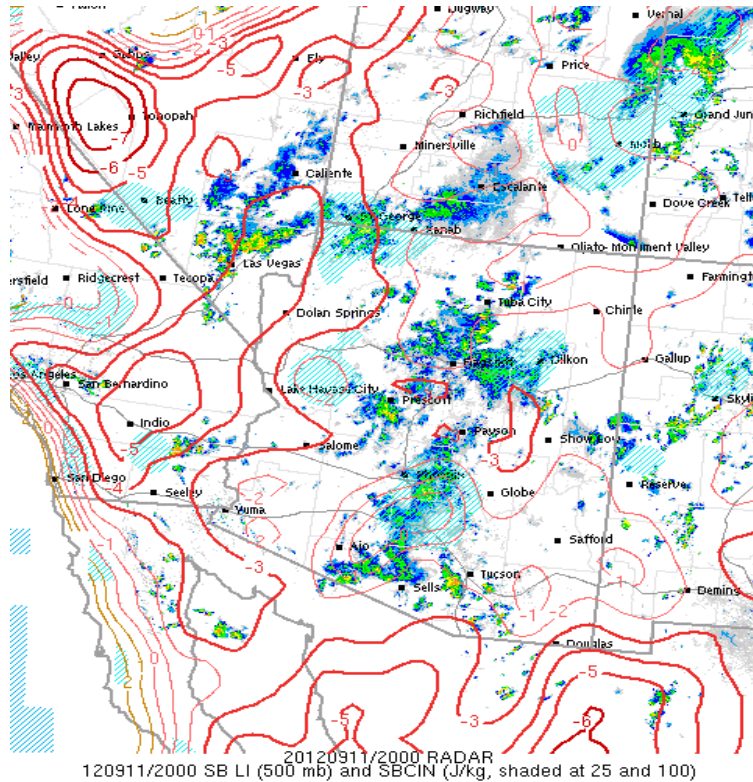
Surface based lifted indices from 20Z September 11, 2012 from the Storm Prediction Center indicated in the red lines overlaid on radar. Note the area of -4 at the time over the eastern side of the Las Vegas Valley.

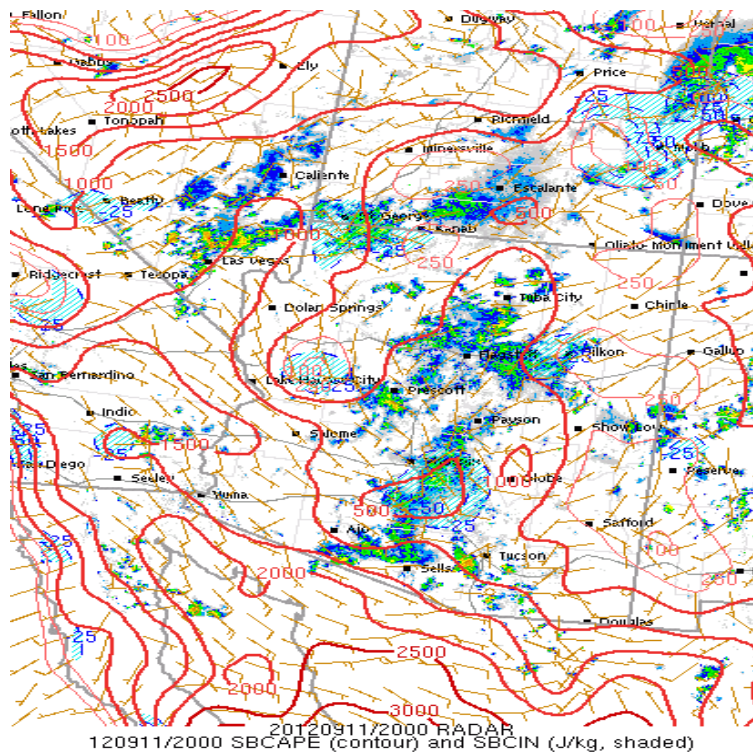
Surface based CAPE from 20Z September 11, 2012 from the Storm Prediction Center indicated in the red lines overlaid on radar.

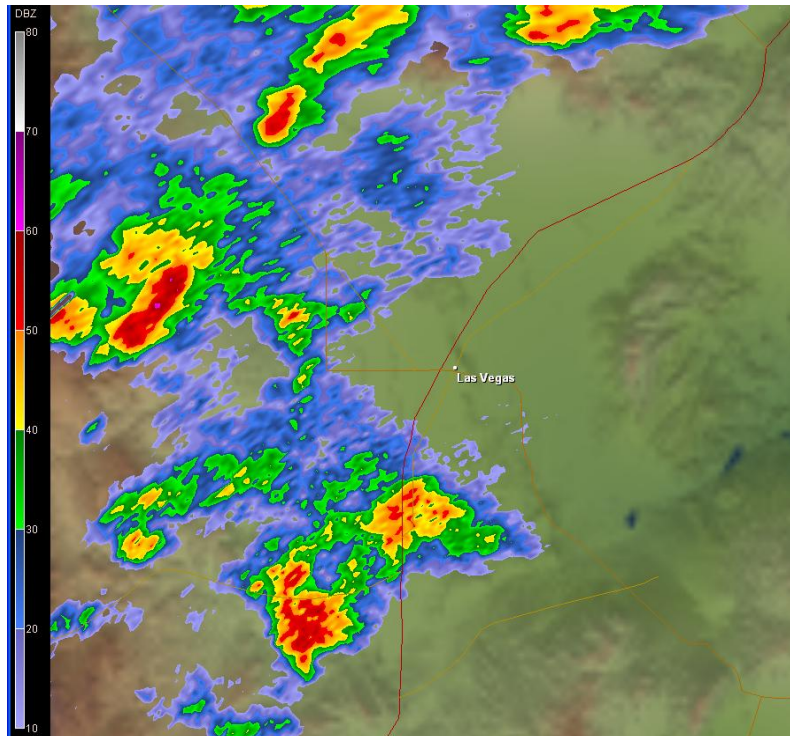
KESX 0.5 degree radar reflectivity at 2005Z on September 11th. Note the brighter colors over the western half of the Las Vegas Valley where heavier rain was falling near Lone Mountain and in the southwest.

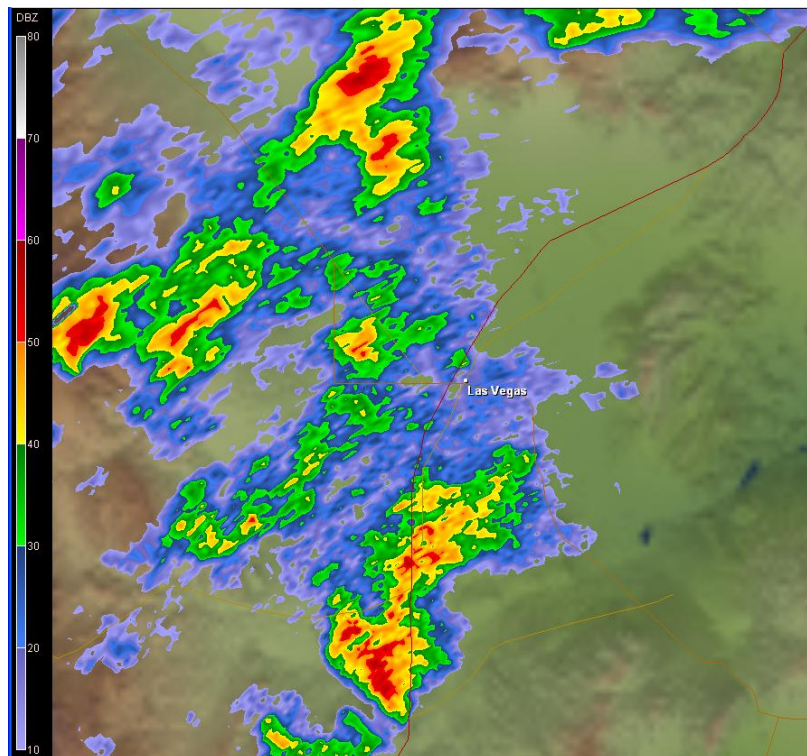
KESX 0.5 degree radar reflectivity at 2017Z on September 11th as thunderstorms started to move east across the valley.

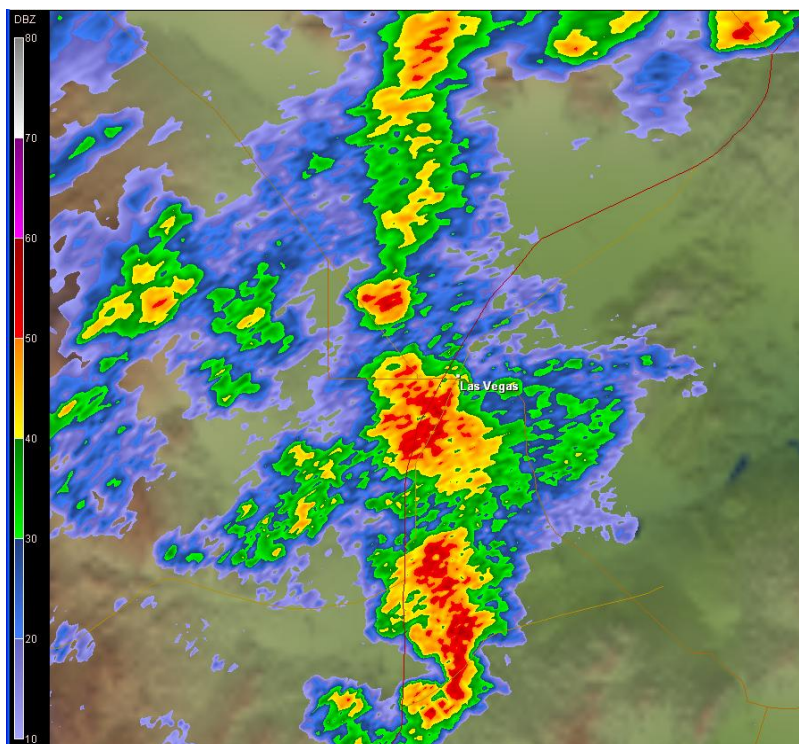
KESX 0.5 degree radar reflectivity at 2030Z on September 11th. Note the brighter colors over the center of the Las Vegas Valley and how a line of thunderstorms had started to form.

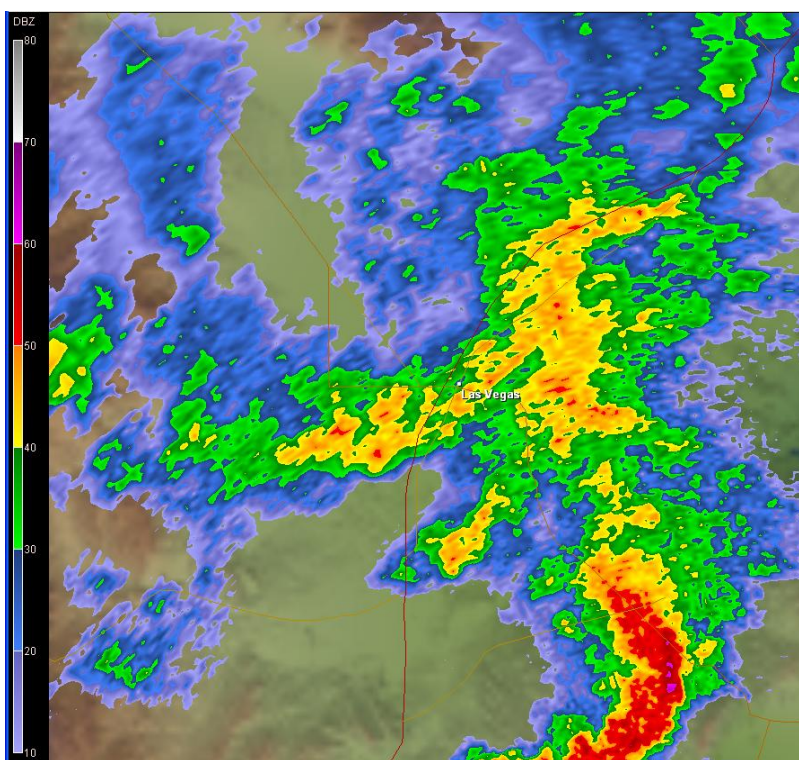
KESX 0.5 degree radar reflectivity at 2105Z on September 11th. Note the brighter colors over the eastern half of the Las Vegas Valley especially the southeast part.

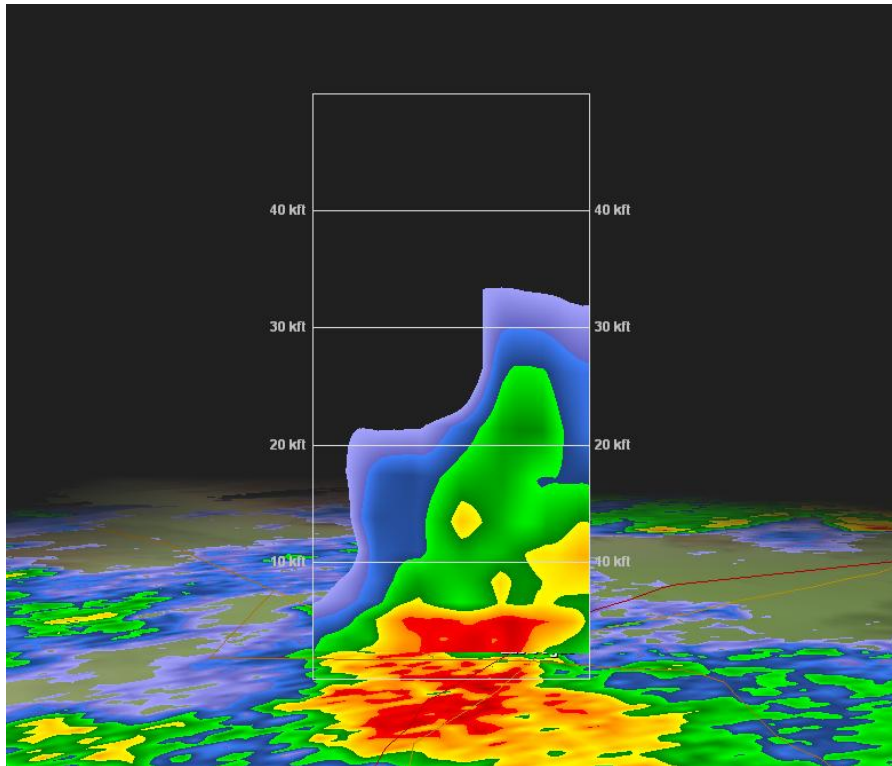
Cross section of a thunderstorm over the center of the Las Vegas Valley just southwest of downtown Las Vegas near 2030Z on September 11th. Note the greatest reflectivities were around 5,000 feet even though the top of the thunderstorm reached to nearly 32,000.

Cross sections of radar showed in general that the greatest reflectivity values were mainly centered at 5,000 feet even in cases where thunderstorm tops built to nearly 30,000 feet. This resulted in an environment where warm rain processes dominated and heavy rain fell from thunderstorms. The Specific Differential Phase (KDP) on the Las Vegas WSR-88D showed values at or above 1 deg/km in several areas across the central and southeast part of the Las Vegas Valley, especially over southeast Henderson where KDP values exceeded 6 deg/km in a small area. With KDP, higher values indicate a greater possibility that heavy rain is falling over a given area.

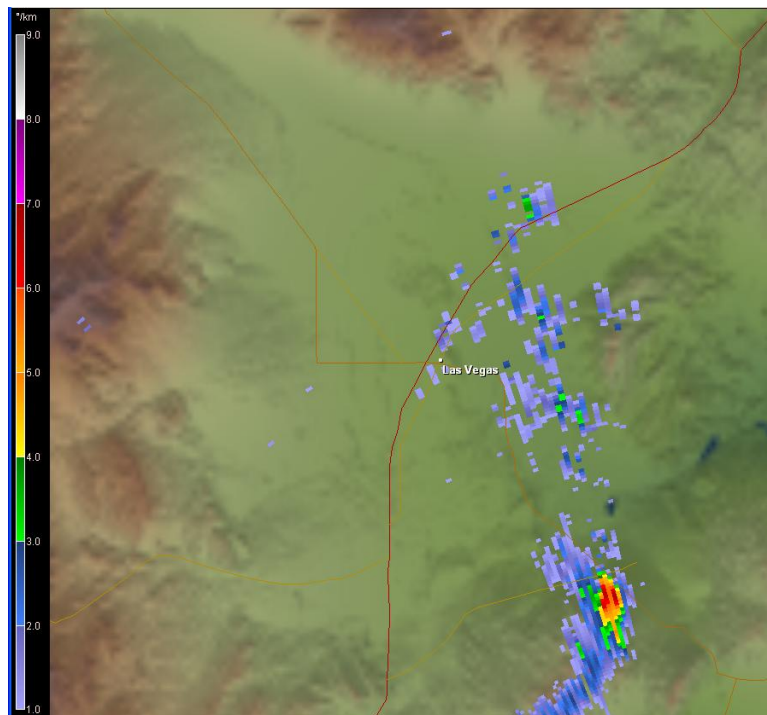
KDP values from the Las Vegas weather radar at 21:01Z on September 11th. Note the area of bright colors over the southeast part of Las Vegas where values approached 6 deg/km. Values below 1.0 deg/km are not shown.

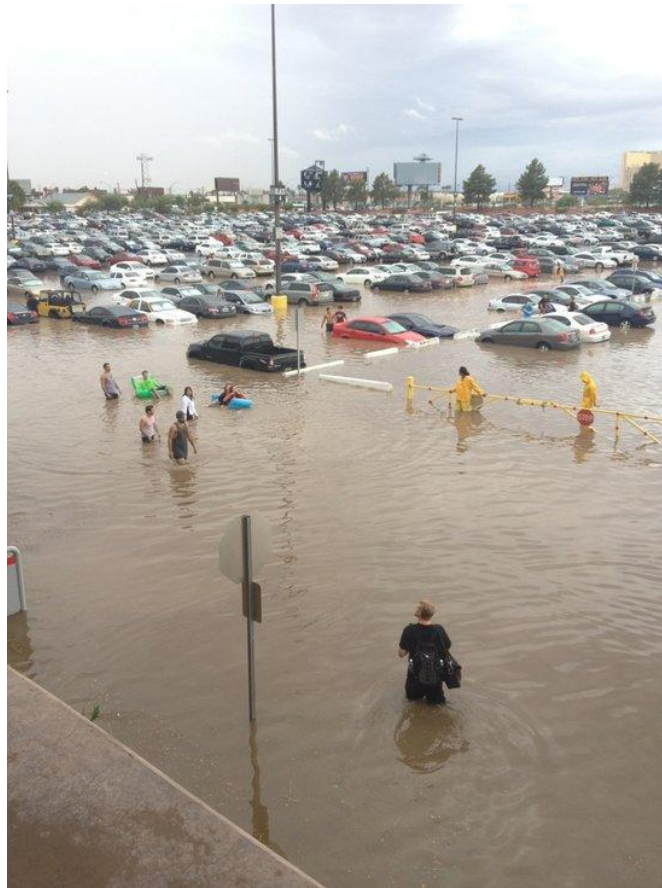
Flooding in the parking lot of UNLV. Photo courtesy: KLAS-TV/Las Vegas.

Flooding was also extensive on the campus of the University of Nevada Las Vegas. Floodwaters entered the TBE Building and also flooded portions of a parking lot south of the Thomas and Mack Center where at least two dozen cars were submerged. Floodwaters also entered a nearby shopping center on Maryland Parkway damaging 10 businesses. Some businesses reported a total loss with damage to furniture and equipment. Water also entered the MGM Grand Garden Arena with about two inches of water collecting in some areas.

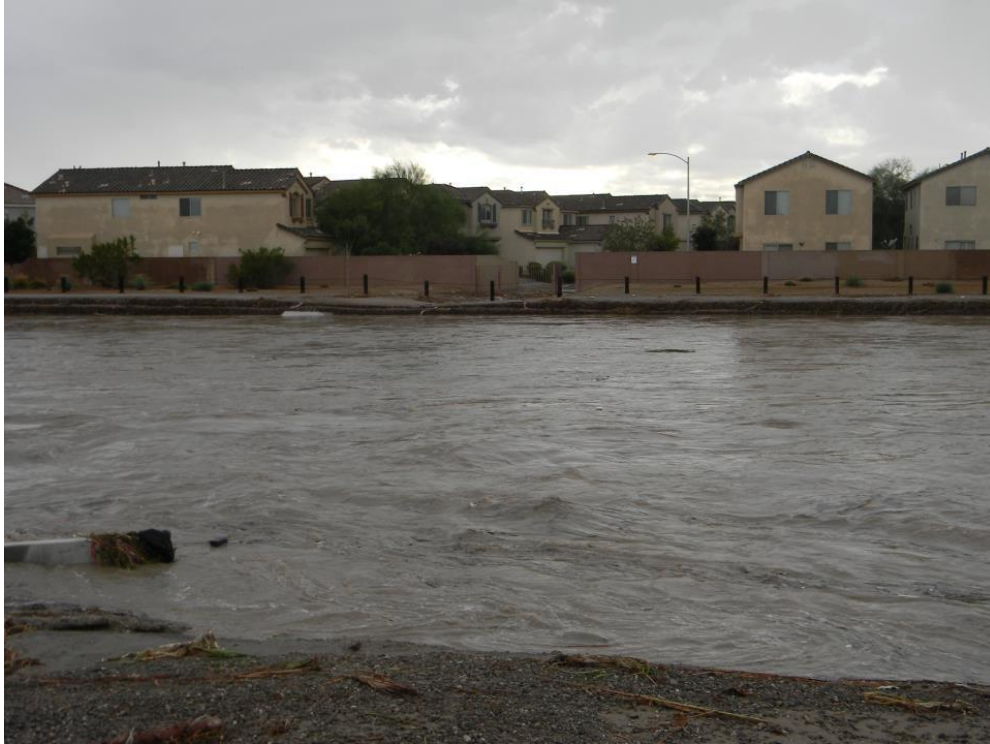
Las Vegas Wash one mile south of Vegas Valley Drive. Photo Courtesy: D. Stoltz.
