# A Hydrologic Assessment of the September 14, 1974, Flood in Eldorado Canyon, Nevada

GEOLOGICAL SURVEY PROFESSIONAL PAPER 930

By PATRICK A. GLANCY *and* LYNN HARMSEN

*A presentation of hydrologic data and interpretations,  
eyewitness accounts of destruction,  
and documentation of flooding*

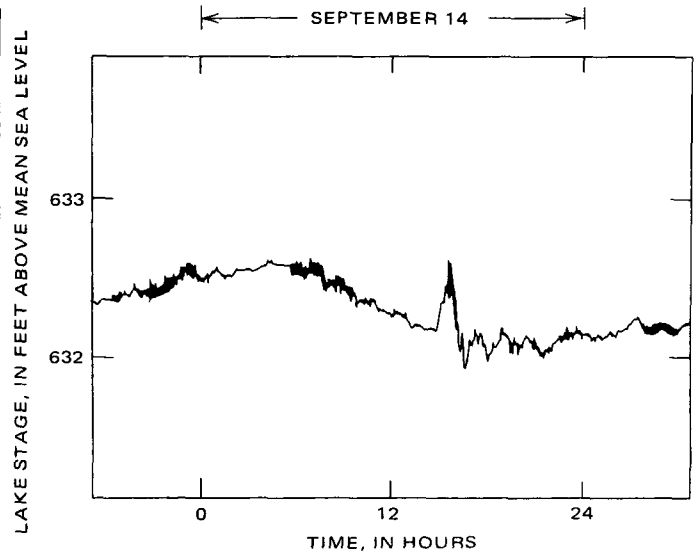
Apparent response of the stage of Lake Mohave at Davis Dam, about 35 mi downstream from Eldorado Canyon (fig. 2), to the flood wave is shown in figure 9. The figure indicates that lake stage rose approximately 0.45 ft shortly after 2:30 p.m. the day of the flood.

FIGURE 9.—Trace of Lake Mohave stage at Davis Dam, showing approximately 0.45-ft rise. Gage is about 35 mi downstream from mouth of Eldorado Canyon. Figure is reproduction of lake stage recorder sheet.

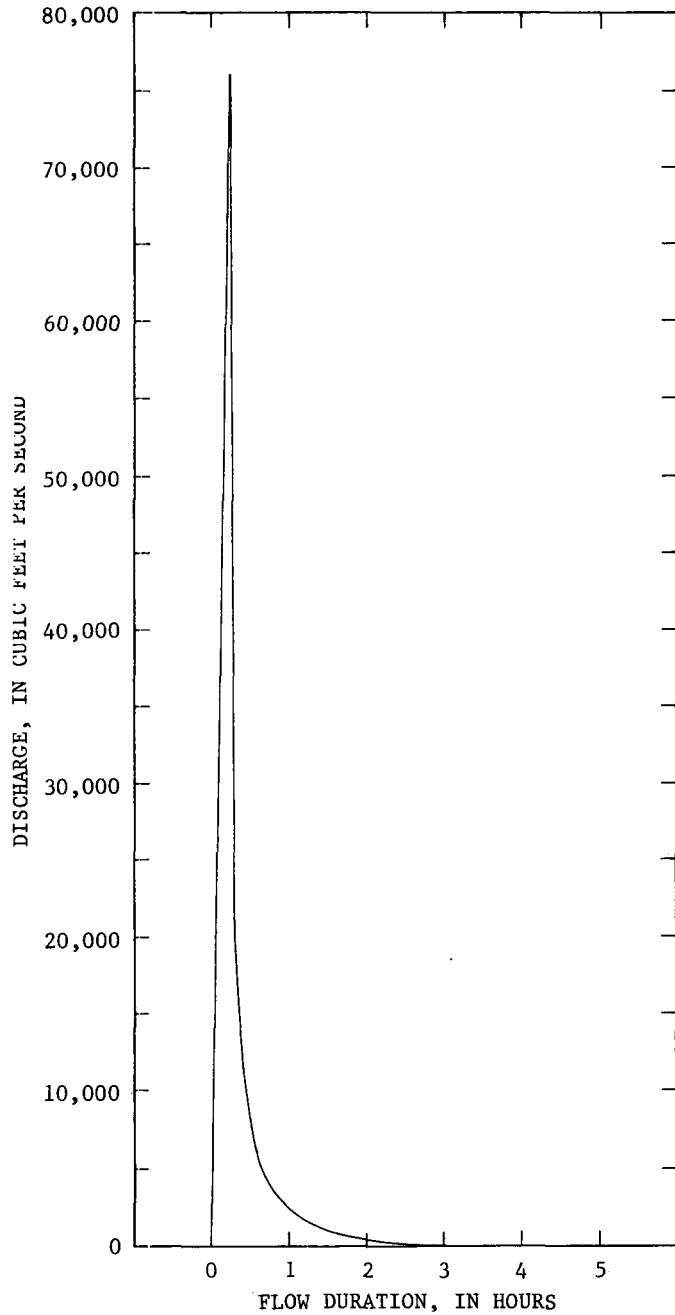
FIGURE 11.—Estimated flood hydrograph for September 14, 1974, near mouth of Eldorado Canyon.

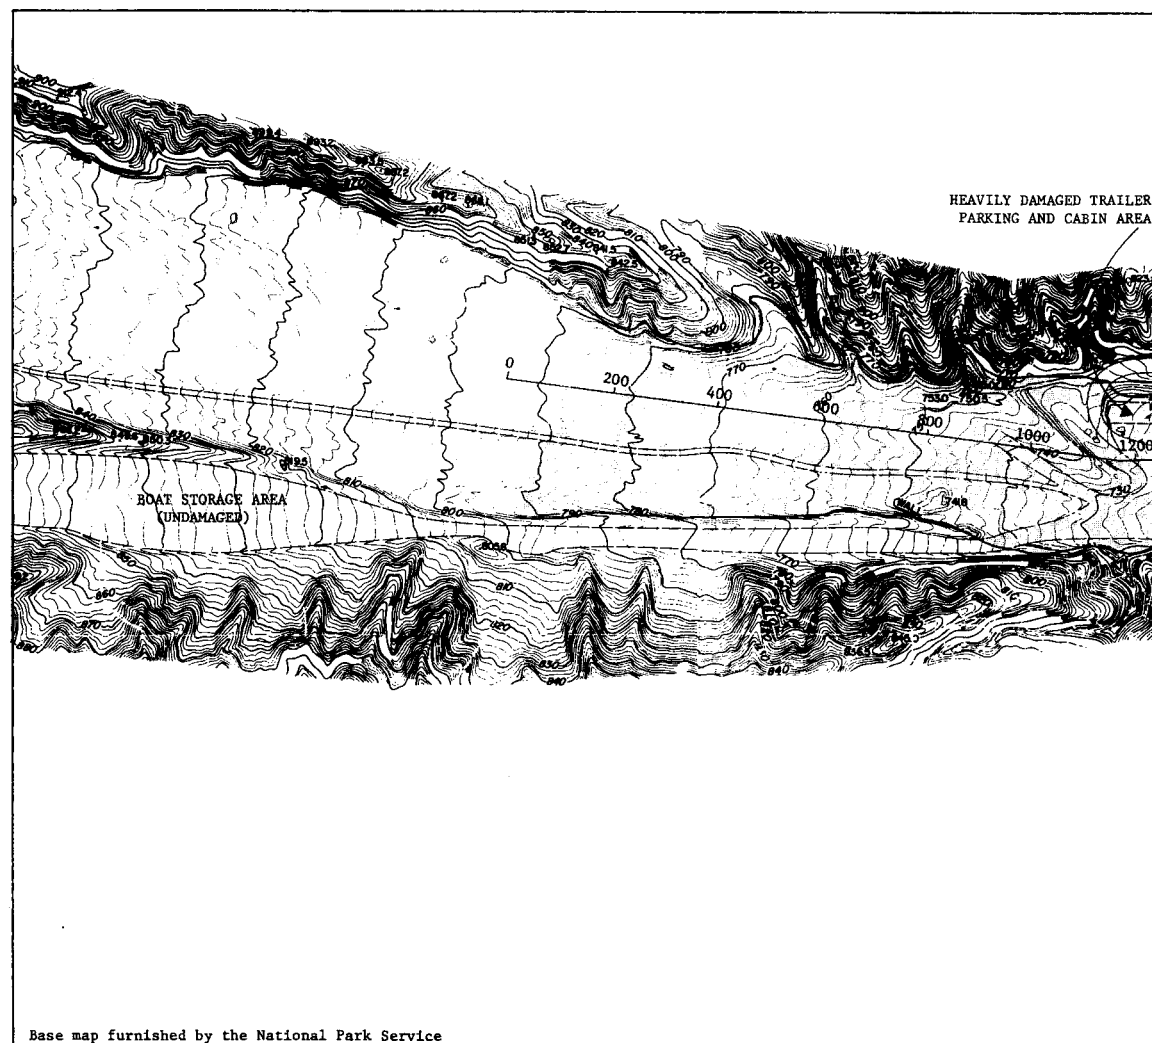
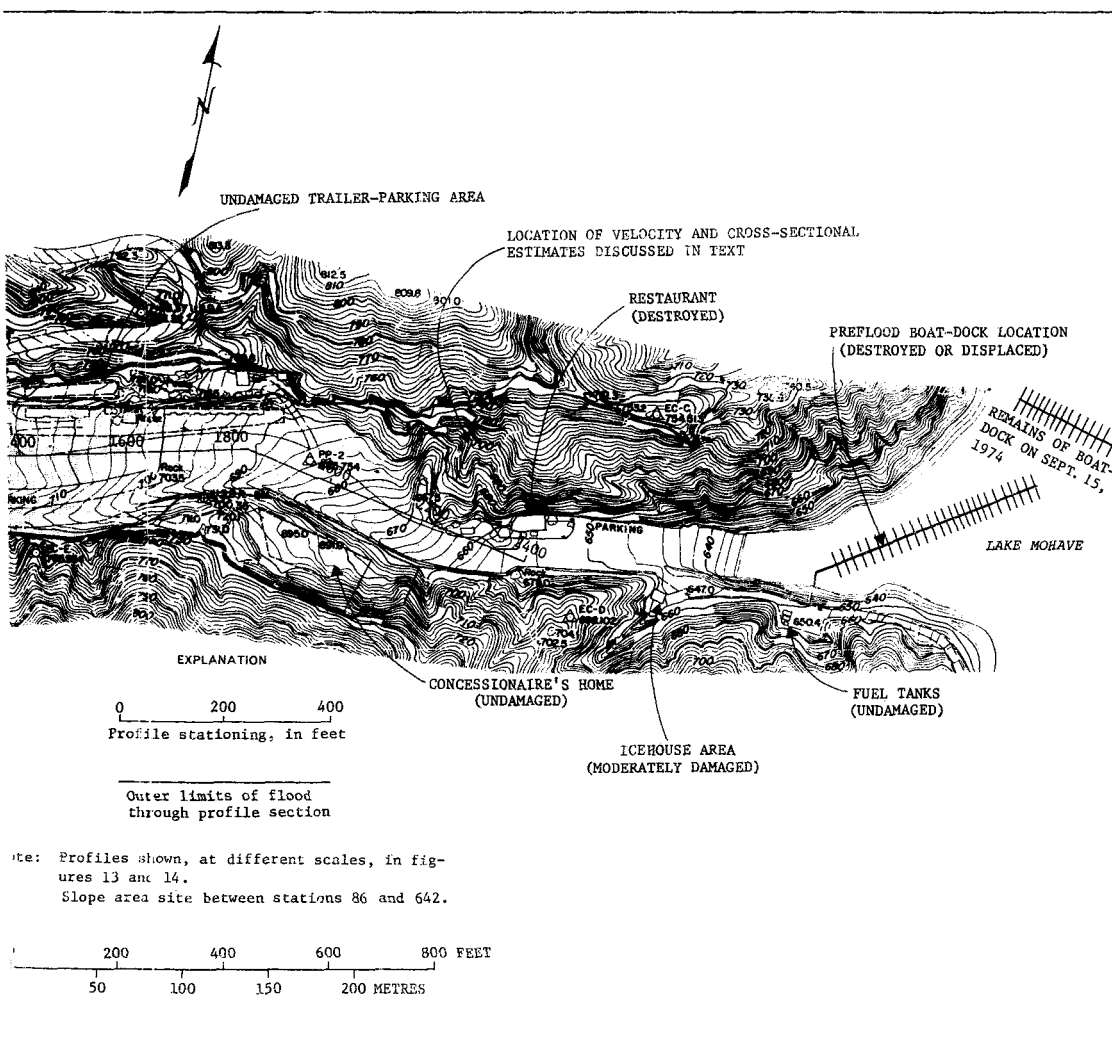
Flow velocity can be estimated in the canyon constriction above the site of the destroyed restaurant (fig. 12), if the estimated 76,000-ft<sup>3</sup>/s peak flow is assumed to have

Kirby L. Koop watched the approach of the initial flood surge from near the icehouse area (fig. 12). He first saw it at a distance of about 100 yd. He recalled the dull thuds of cars caught up in the surge striking the canyon walls. According to Koop, when the mass of debris and water arrived at the preflood shoreline of Lake Mohave, it possessed such momentum that it appeared to "hydroplane" over the lake surface as far as the boat dock gangway (a distance of 100 to 150 ft, scaled from fig. 12). The mass then seemed to fall vertically into the lake.

FIGURE 12.—Flood boundaries, streambed

profile line, and specific cultural features.

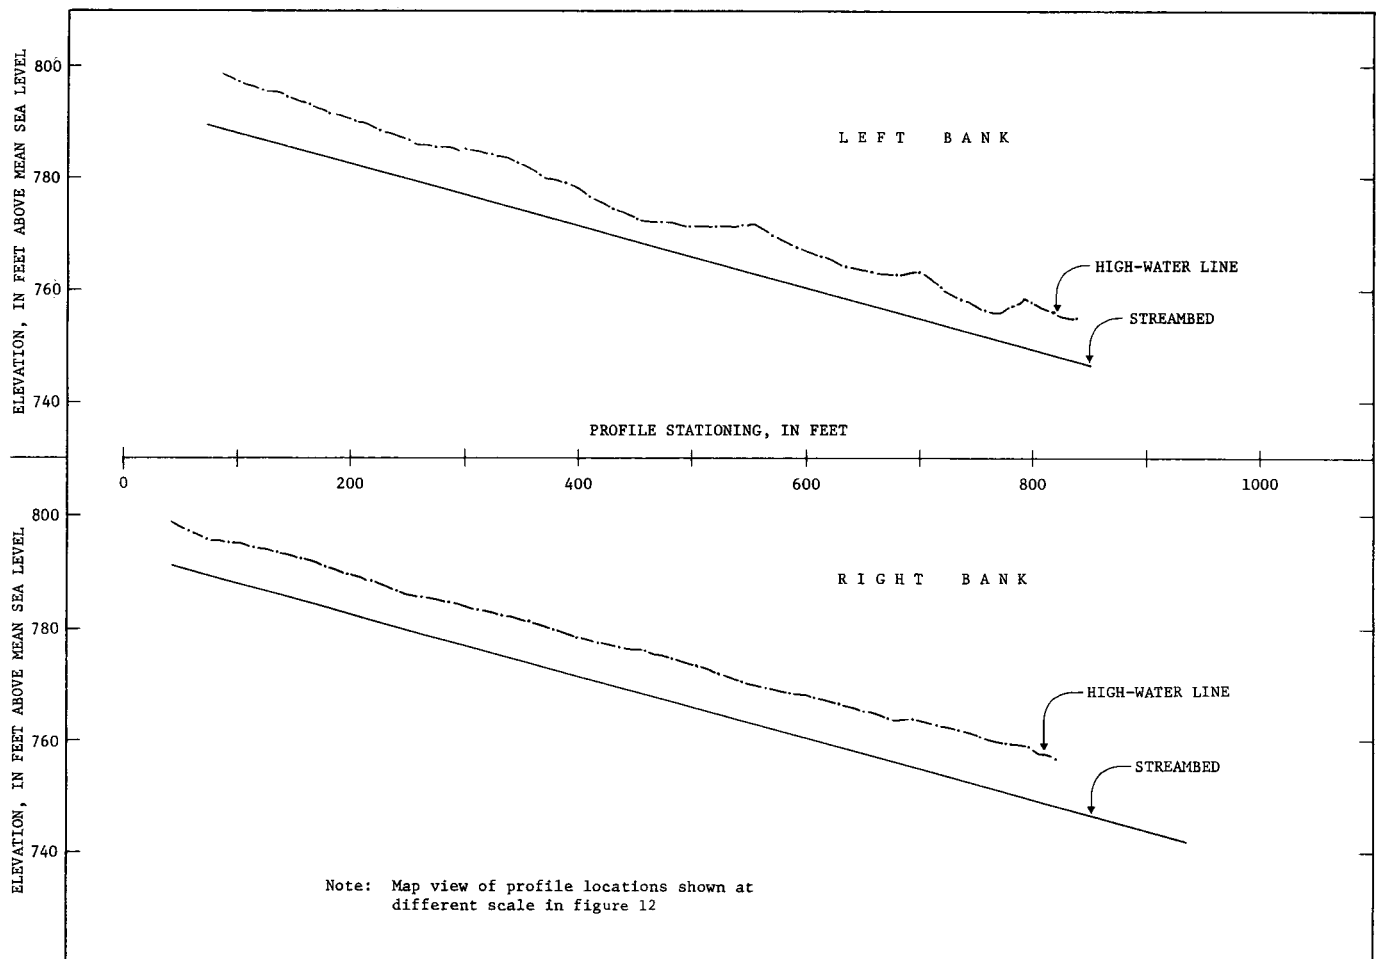
Figures 12, 13, and 14 show locations of flood boundaries, high-water profiles, streambed profiles, and a qualitative assessment of damage to some cultural features in Eldorado Canyon. Figure 15 shows the general flood plain extent and characteristics just above the developed area. The average slope of the profiles in the measured reach (fig. 12) is 280 ft/mi. The left-bank profile through the trailer park area indicates a 2- to 4-ft depth of water above the canyon floor (figs. 14 and 16), whereas the right-bank profile in the same section is defined by one piece of debris found on the vertical wall about 16 ft above the canyon floor. Assuming that this piece of debris actually represents the true water surface along the right bank, the difference in left- and right-bank elevations must be explained by the sloshing of water from bank to bank (figs. 12, 7A), and by local pileup of water caused by cars and boat trailers in the parking area. Downstream from the trailer parking area (fig. 14), the left- and right-bank profiles become very erratic and indicate water pileup due to the contraction of the reach. The momentum of the flowing water forced the water up and over the projecting bed-rock ridges. The profiles (fig. 14) show that the water surface along the left bank was as much as about 25 ft above the canyon floor where the flow was pushed up and over the projecting rock ridge. Figure 16 shows the contrast between trailers caught within the left-bank high water line (damaged) and those on slightly higher ground (undamaged).

FIGURE 13.—Profiles of peak discharge high water lines and streambed at slope-area site in Eldorado Canyon.

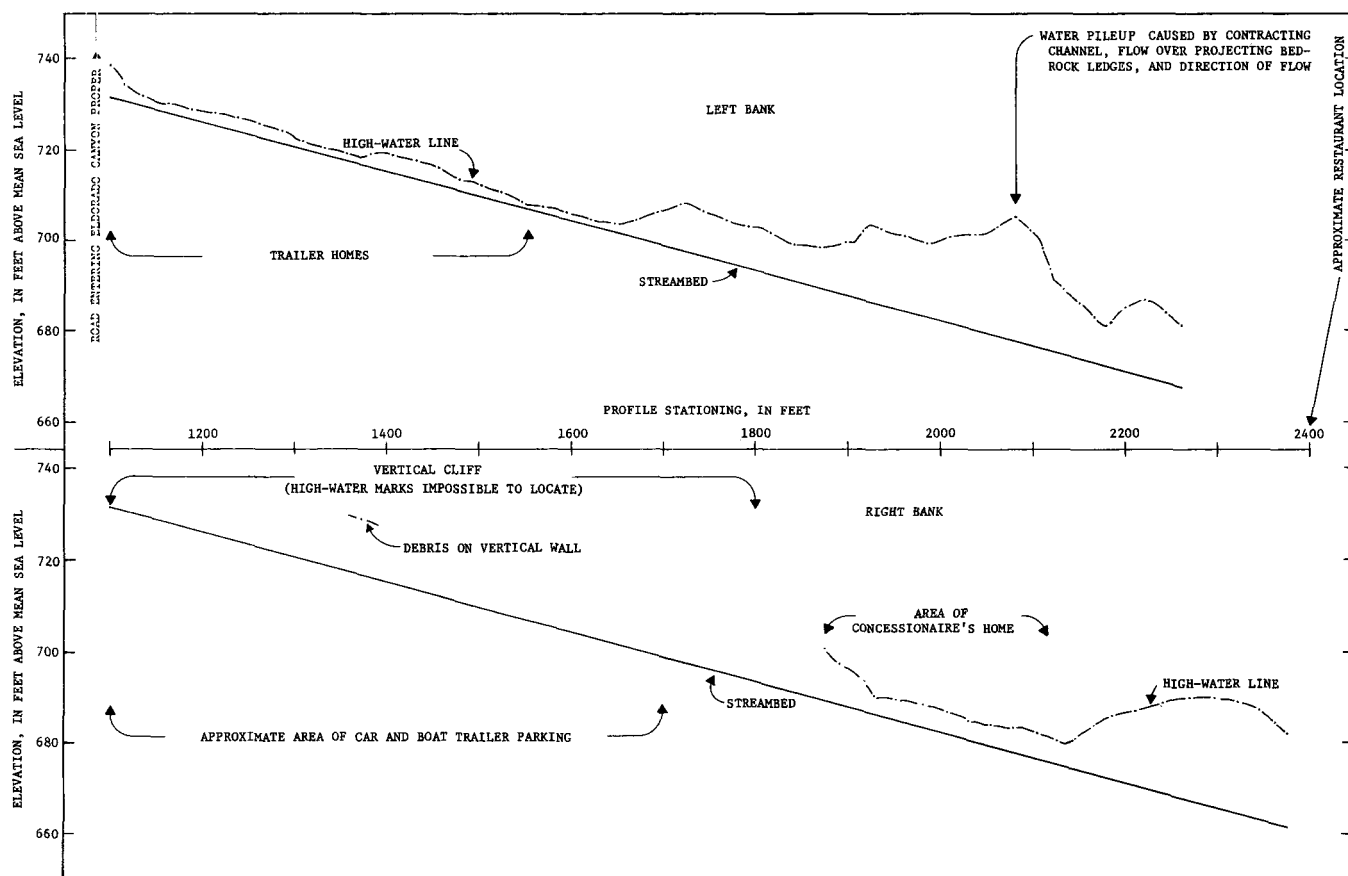
FIGURE 14.—Profiles of peak discharge high water lines and streambed, Eldorado Canyon Resort.

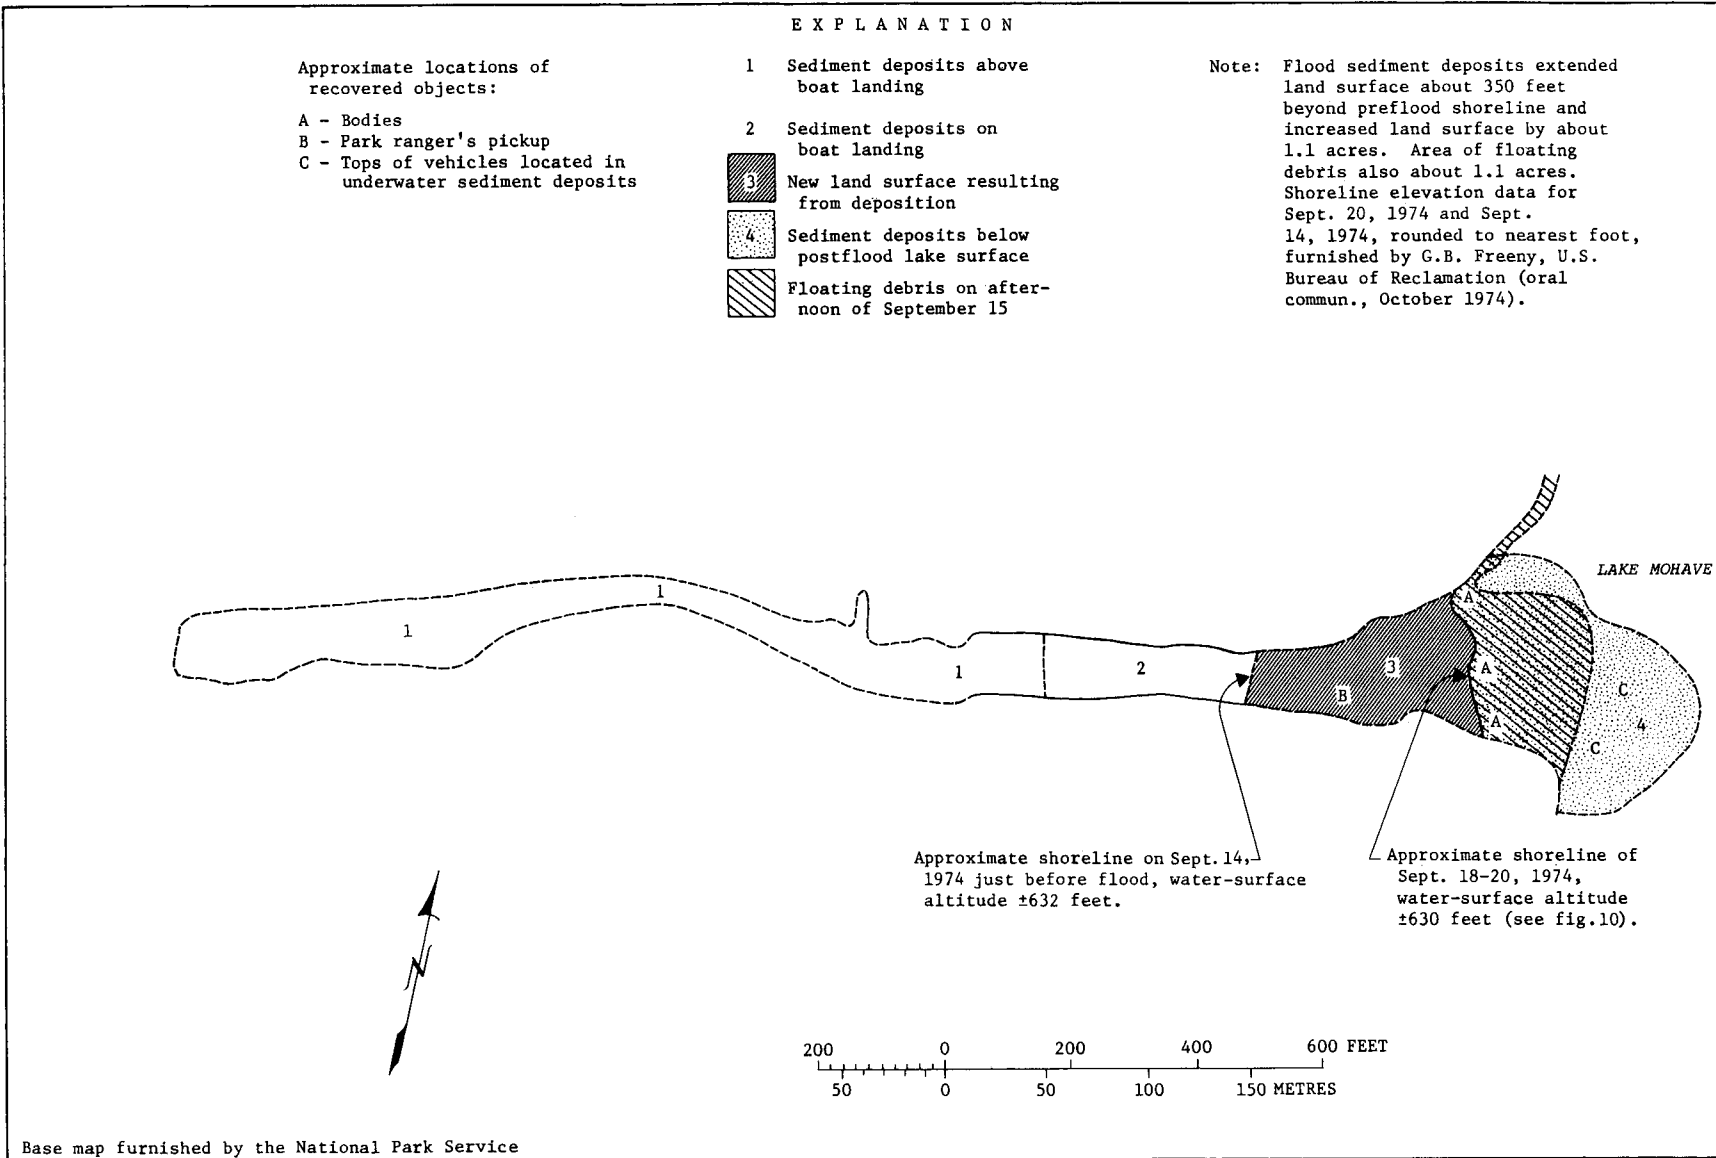
The sediment volume accounted for in known deposits is estimated to be 54,000 yd<sup>3</sup>. Table 4 describes the location and distribution of the known sediment deposits; location of the depositional units is shown in figure 17. The estimate was made on the basis of post-flood configuration of deposits and on some preflood topographic information. Estimates of deposits upstream from the preflood shoreline of Lake Mohave probably are reasonably accurate because detailed preflood topographic data were available. However, no recent preflood bathymetric data were available for the harbor or adjacent areas. Some general knowledge of preflood water depths is available from observations by the National Park Service staff and others. These sparse data are supplemented with estimates of the quantity of material actually excavated and removed, as well as evidence of depths to apparent preflood lake-bottom clays exposed during excavation.

Figure 17 shows the approximate area of new land surface created in the harbor as a result of sediment deposition. New land surface was delineated on the basis of the preflood topography shown in the figure and

FIGURE 17.—Sediment deposits and locations of preflood and postflood shorelines.
